## #8. Superintendent's Cottage

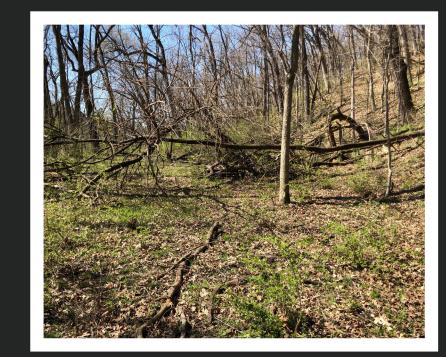
Overview of former Superintendent's Cottage in 2020, facing west.

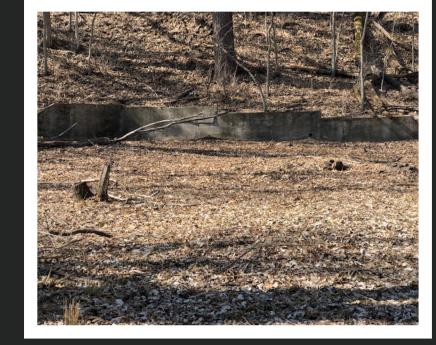
Overview of retaining wall behind cottage in 2021, facing north.

This cottage featured three concrete retaining walls, in an inverted U-shape, behind the rear of the cottage. It also included a large artificially leveled yard, a long angular driveway connecting the house to the Lower Road, and two sets of sidewalks and steps: one from the highway to the Lower Road and the second from the Lower Road to the cottage. East of the cottage are three undocumented concrete features: a 1-stall garage concrete foundation, a concrete parking slab abutting the garage, and a concrete foundation wall line extending from the garage toward the cottage. Artifacts near the garage foundation included: bottle glass (amethyst, clear, amber, and brown); container glass (Mason jars); yellow- and pink-glass bowls; window glass; ceramics (earthenware, porcelain, ironstone, stoneware); bricks; coal and coal slag; and mussel shells. Date ranges for the assemblage indicate occupation from early 1900s to 1950s.
