Final Big Hollow Watershed Management Plan Des Moines County, Iowa

18 April 2022

Re: Dam Inspection Findings and Recommendations

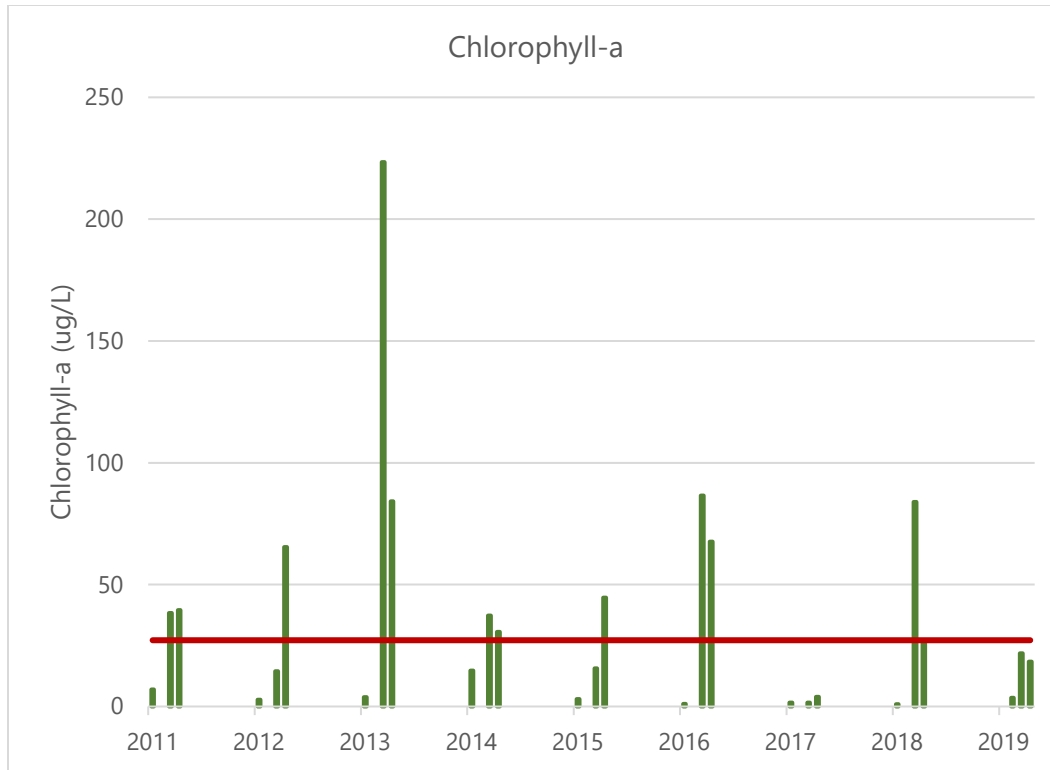
Figure 4-3. Chlorophyll-a Concentrations

Chlorophyll is a green substance found in plants that is essential for photosynthesis. Chlorophyll-a is a specific pigment commonly used to measure algal biomass present in lakes. Chlorophyll-a TSI scores exceed the 303(d)-list threshold of 65 approximately 40% of the time during the assessment period of 2011-2019 (Figure 4-3). Chlorophyll-a concentrations ranged from 1.0 ug/L to 223.4 ug/L. To be delisted, Chlorophyll-a TSI scores need to be 63 or lower for two consecutive years, which is equivalent to a concentration of 27.2 ug/L or lower (see concentrations and red line in Figure 4-3).

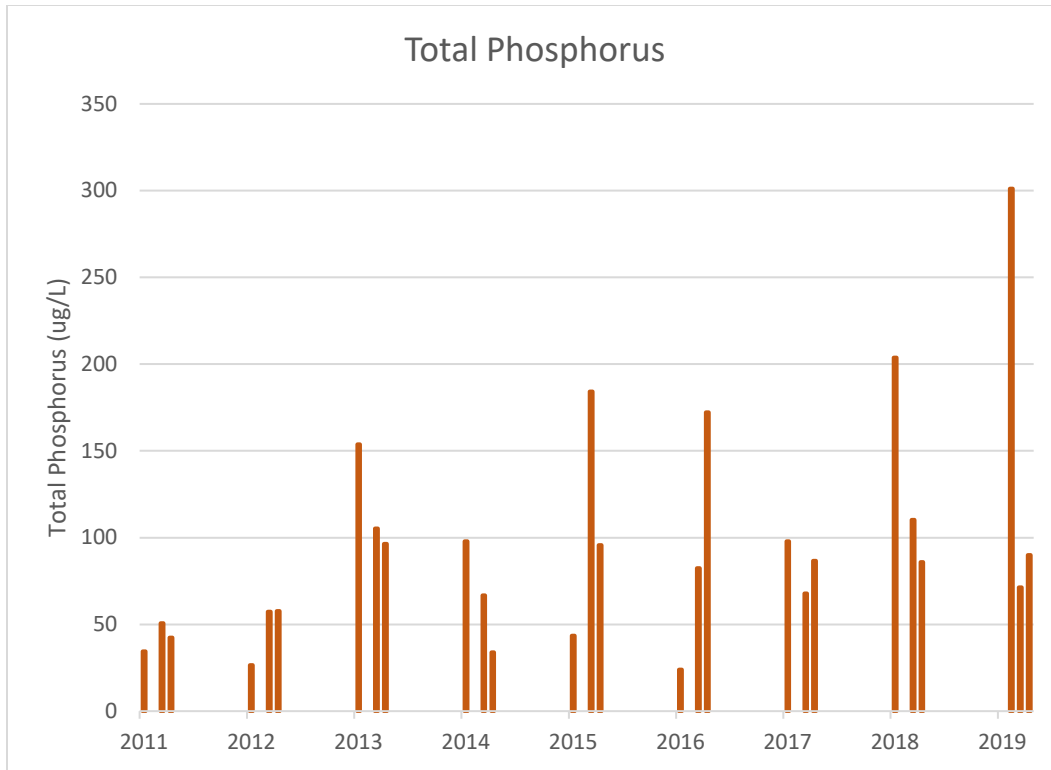
Figure 4-4. Total Phosphorus Concentrations

Phosphorus is a nutrient that is critical to plant growth. It is often a limiting nutrient in freshwater ecosystems. Excessive amounts of phosphorus can trigger algae blooms and lowering phosphorus can lessen the density and frequency of nuisance algae. From 2011-2019, Total Phosphorus concentrations in Big Hollow Lake increased significantly (Figure 4-4). Concentrations exceeding 100 ug/L are considered extremely high and reflective of hypereutrophic conditions. The lake had concentrations at or above this level in 7 consecutive years (2013-2019). This was sufficient to cause extreme algal growth, and blooms would have been even more severe during this period but were limited by other factors, such as turbidity caused by fine, clay particles that block sunlight. Even if high Total Phosphorus levels are not currently causing extreme algal blooms and Chlorophyll-a concentrations, over time, much of this phosphorus will accumulate in the sediment at the bottom of the lake and could cause future water quality problems. Additional water quality data is provided in Appendix B.

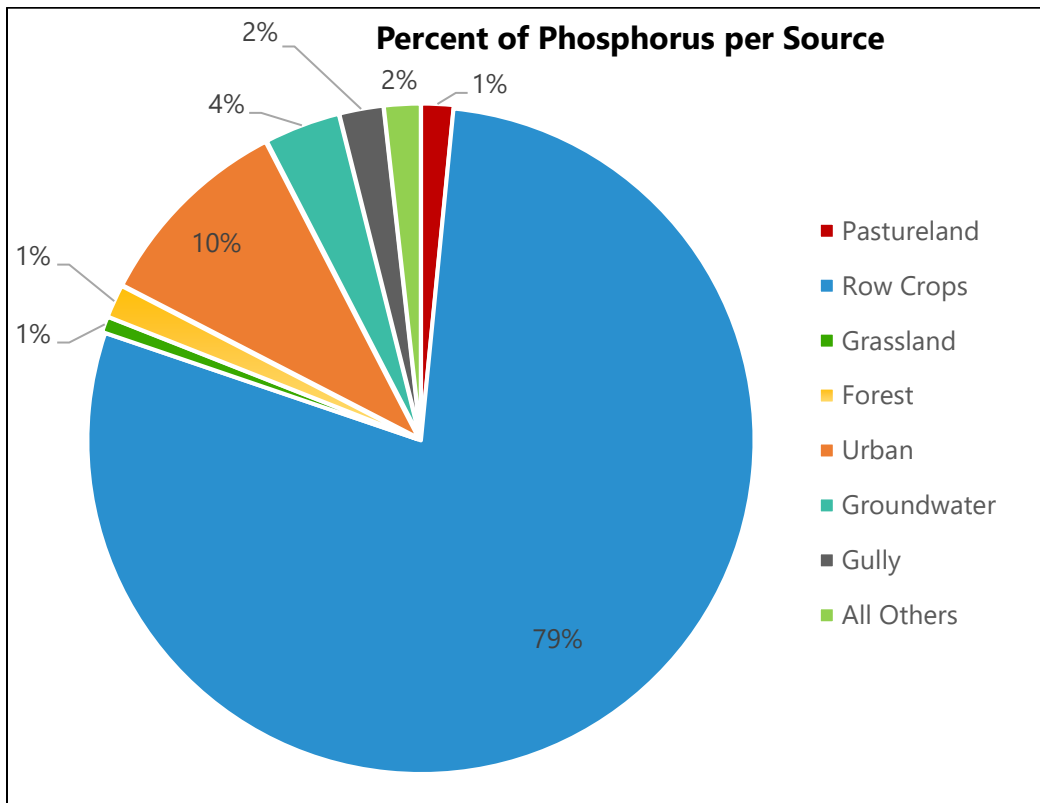
Figure 5-1. Percent of Phosphorus per Source

Nonpoint sources of phosphorus to Big Hollow Lake include erosion from land in pasture and row crop production, land applied manure, erosion from grasslands, erosion from woodland areas, transport from developed areas, wildlife defecation, atmospheric deposition (from dust and rain), and subsurface tiles and groundwater contributions. Septic systems in the watershed can fail or drain illegally to ditches and contribute phosphorus, nitrogen, and bacteria to the lake. Based on the STEPL modeling, the major sources of phosphorus to Big Hollow Lake include erosion from row crops, non-grazed grassland, and pastureland (Table 5-3). Row crops comprise 70% of the watershed while contributing 79% of the phosphorus loads to the Lake.

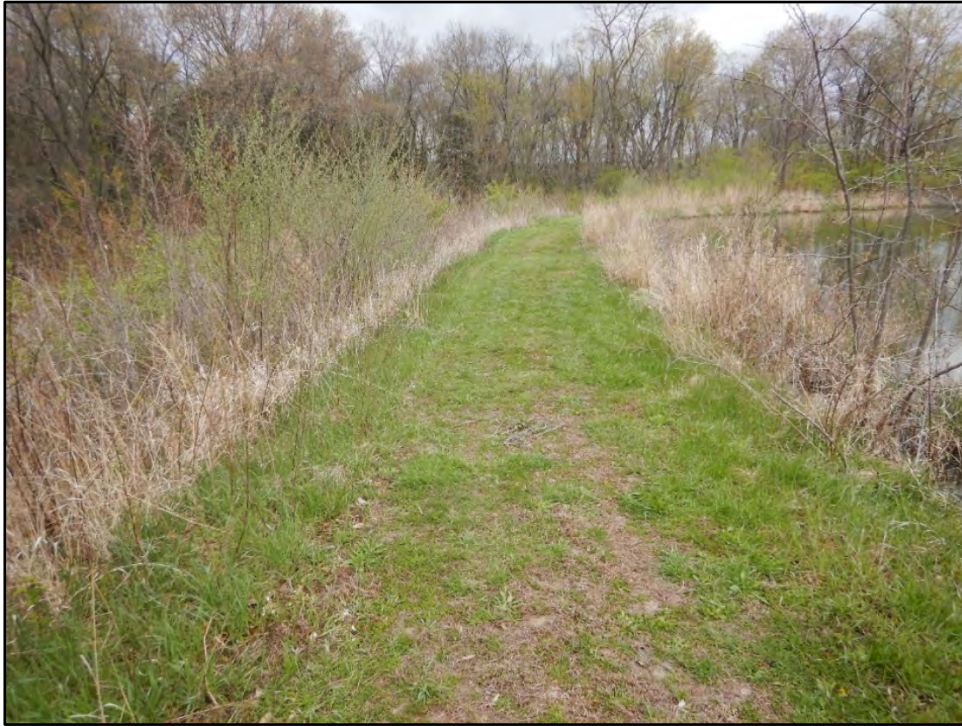
Figure 1: Photo taken on 4/20/21 showing the dam alignment with trees and brush growing on upstream and downstream slopes.

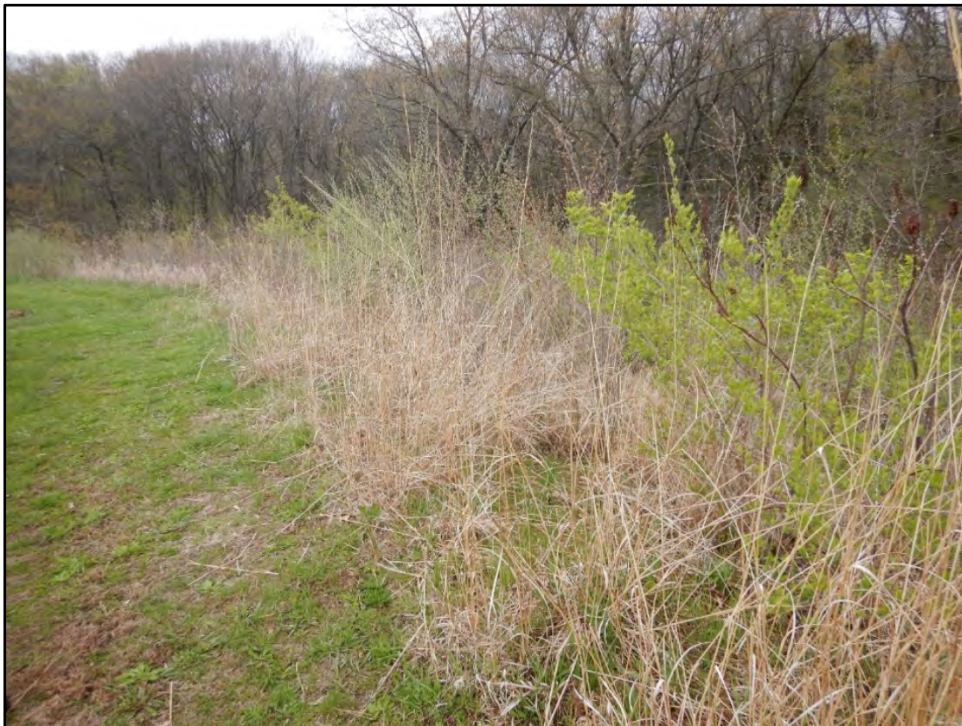
Figure 2: Photo taken on 4/20/21 showing the trees and brush growing on downstream slope of the dam.

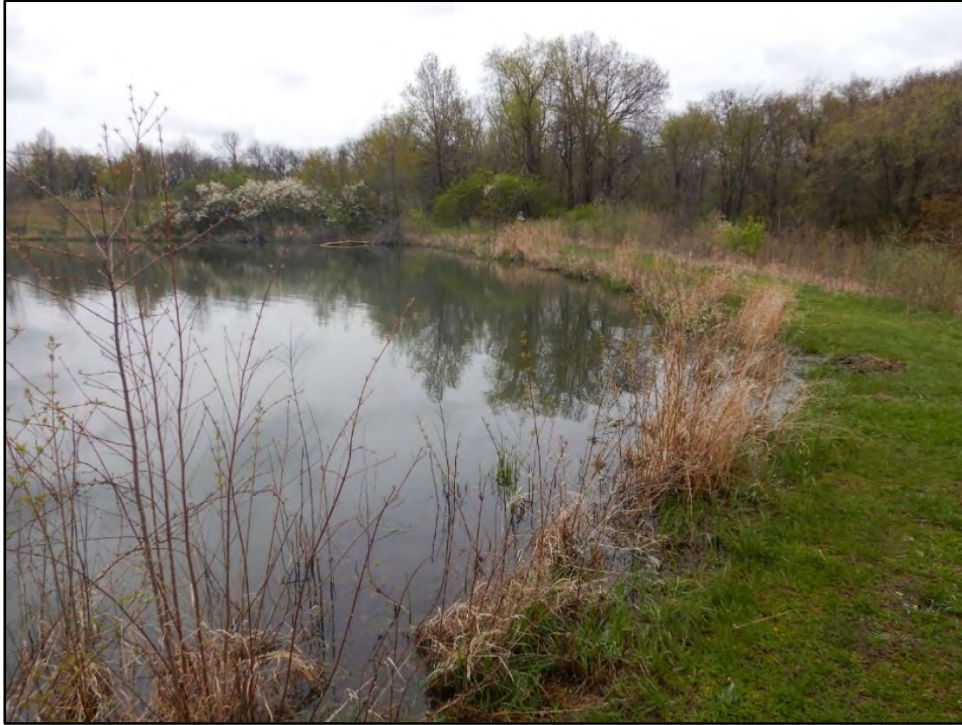
Figure 3: Photo taken on 4/20/21 showing the upstream slope of the dam and elevated pool.

The pond's pool appeared to be higher than the design elevation, likely due to a partially clogged principal spillway pipe inlet. The principal spillway inlet could not be located as it was submerged under the water surface and/or buried within the vegetation on the front face of the dam. Seepage was observed on the downstream face of the dam with moving water along the principal spillway pipe alignment (Figure 8 in Appendix). This is likely from "piping" of water along the pipe or a leaking pipe joint, which can cause internal erosion within the dam as water picks up sediment particles near the pipe and transports them causing erosion. Over time, this void can grow larger and compromise the structural integrity of the dam embankment (Figure 4). Piping is the most common cause of failure in earthen dams.

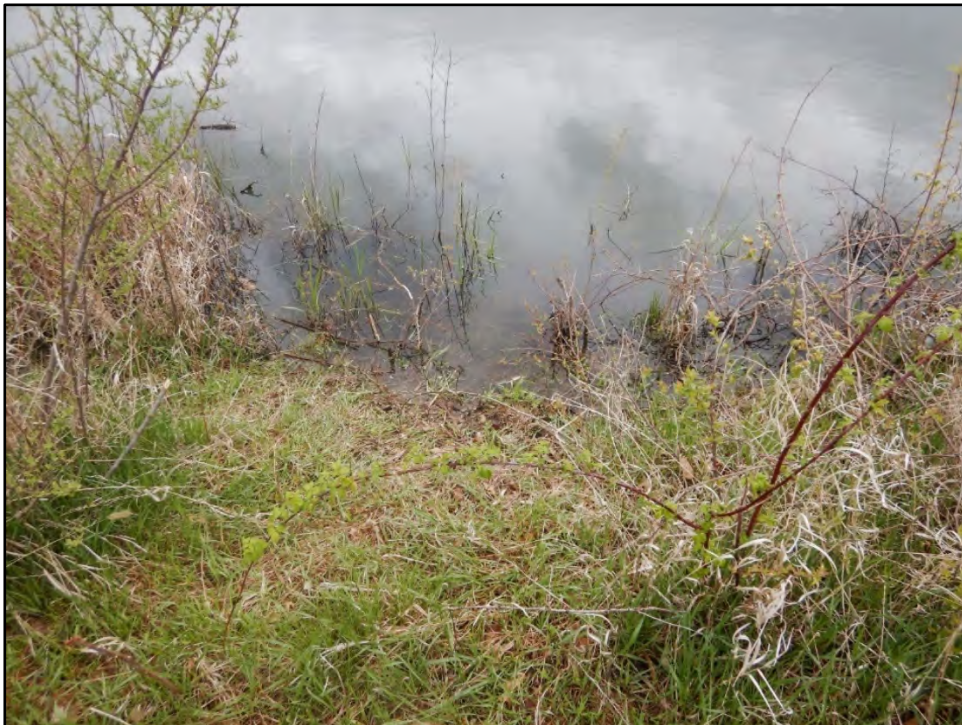
Figure 4: Photo taken on 4/20/21 at approximate location of the submerged principal spillway inlet.

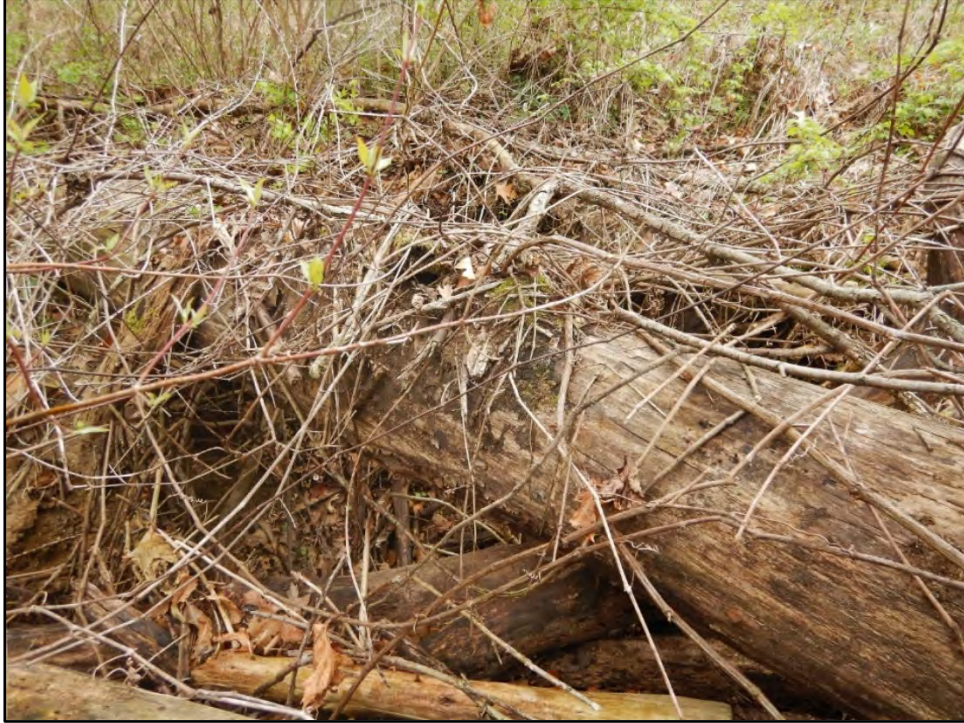
Figure 5: Photo taken on 4/20/21 showing debris surrounding the spillway outlet.

inspections. The outlet pipe was hidden under debris and the outlet channel is slightly degraded with some scouring.

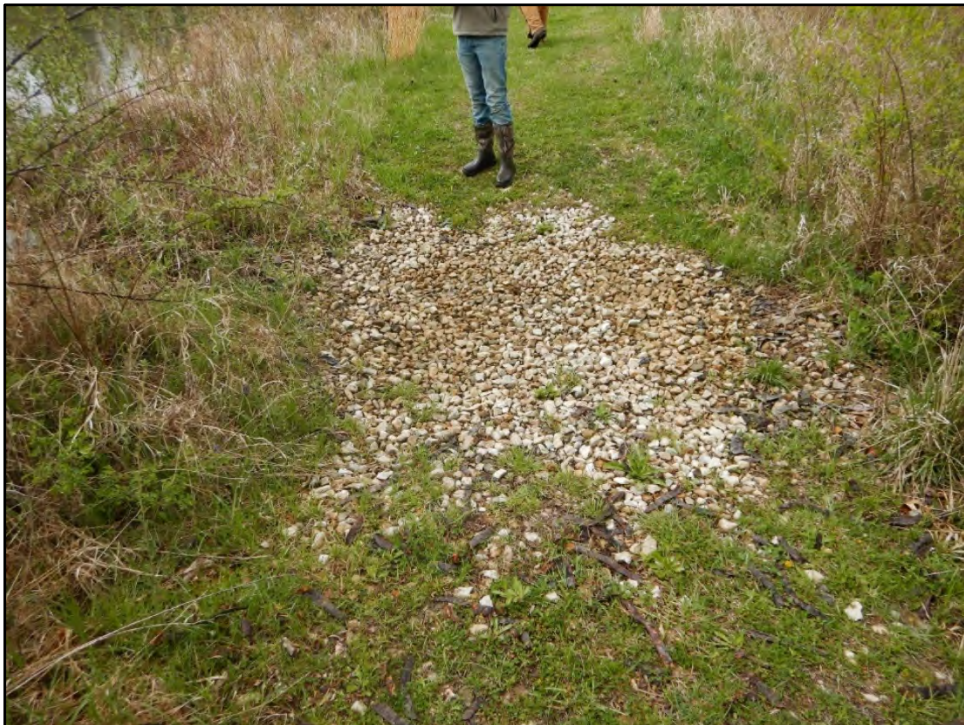
Figure 6: Photo taken on 4/20/21 showing earth cut auxiliary spillway.

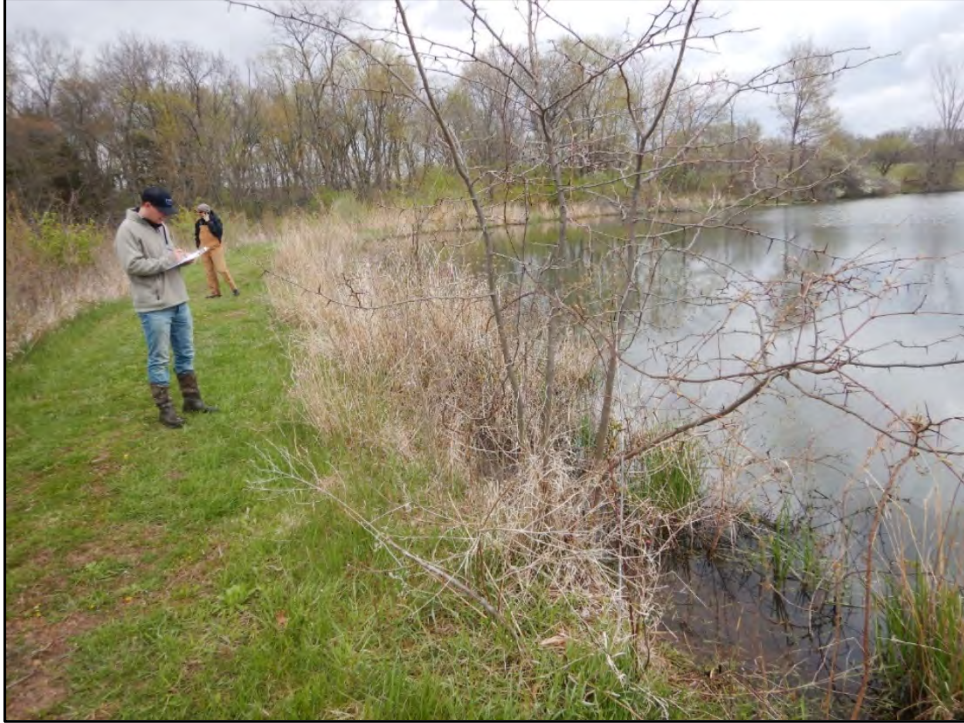
Figure 7: Photo taken on 4/20/21 showing trees growing at the water line.

Trees and brush were observed growing on the embankment. The roots of the trees and brush can penetrate deep into the embankment, act as seepage paths for water through the embankment, harbor animals, and hide any other deficiencies on the structure. Additionally, if the trees are ever uprooted, they can create large voids in the embankment. Trees and woody brush and their root systems should be cleared from the embankment to prevent future damage to the structure and help the future maintenance and ease of

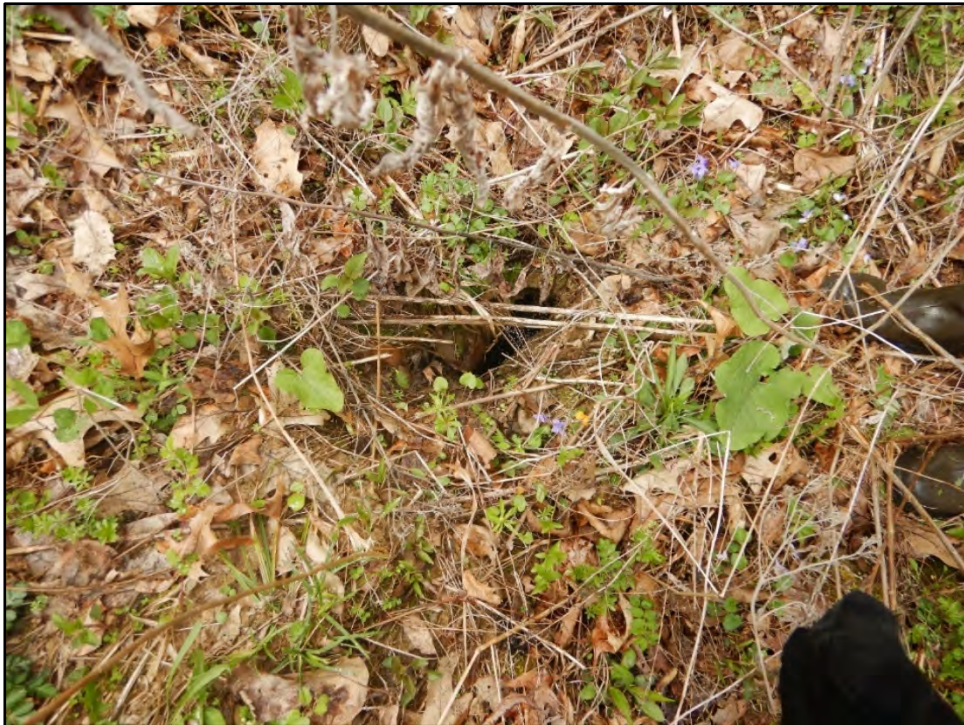
Figure 8: Photo taken on 4/20/21 showing seepage hole with running water along the principal spillway alignment.

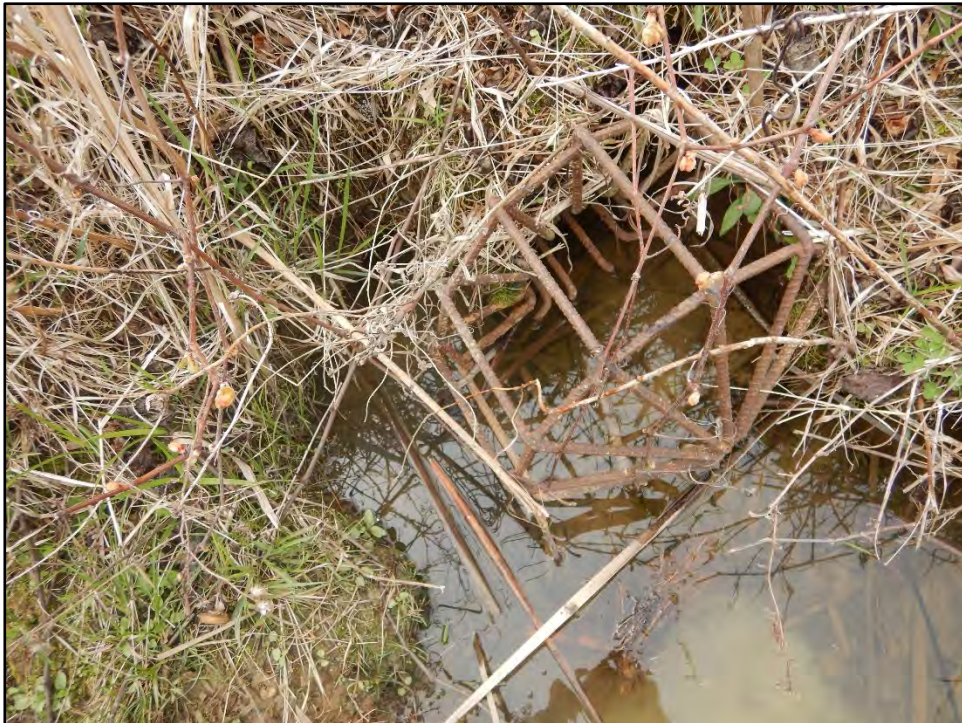
Figure 12: Photo taken on 4/20/21 showing 6" CMP principal spillway inlet with rebar trash rack.

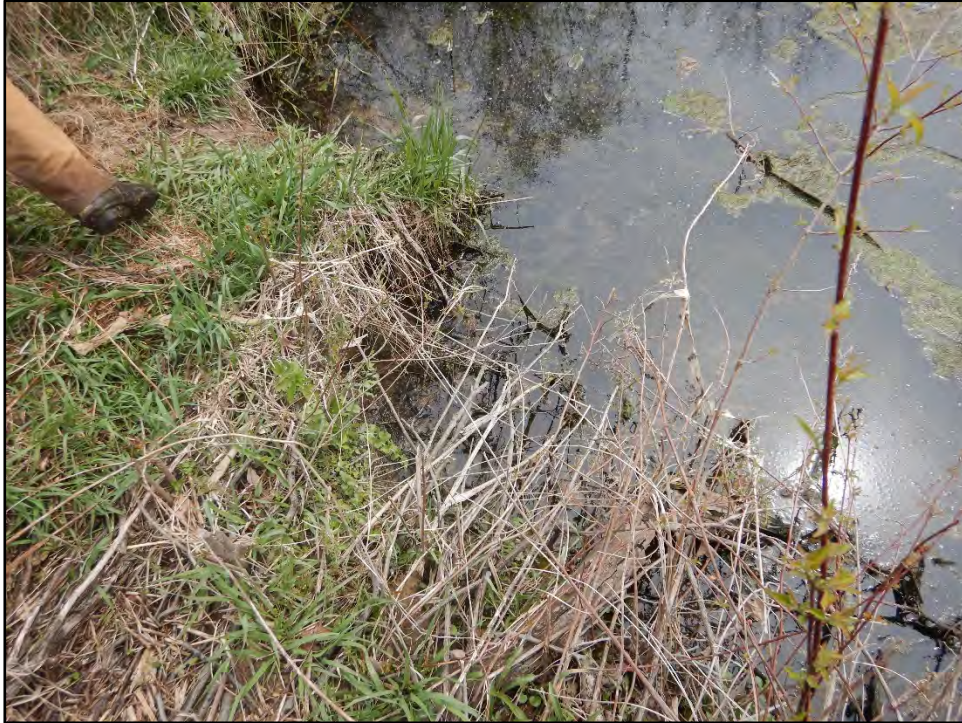
Figure 13: Photo taken on 4/20/21 showing approximate location of submerged principal spillway outlet.

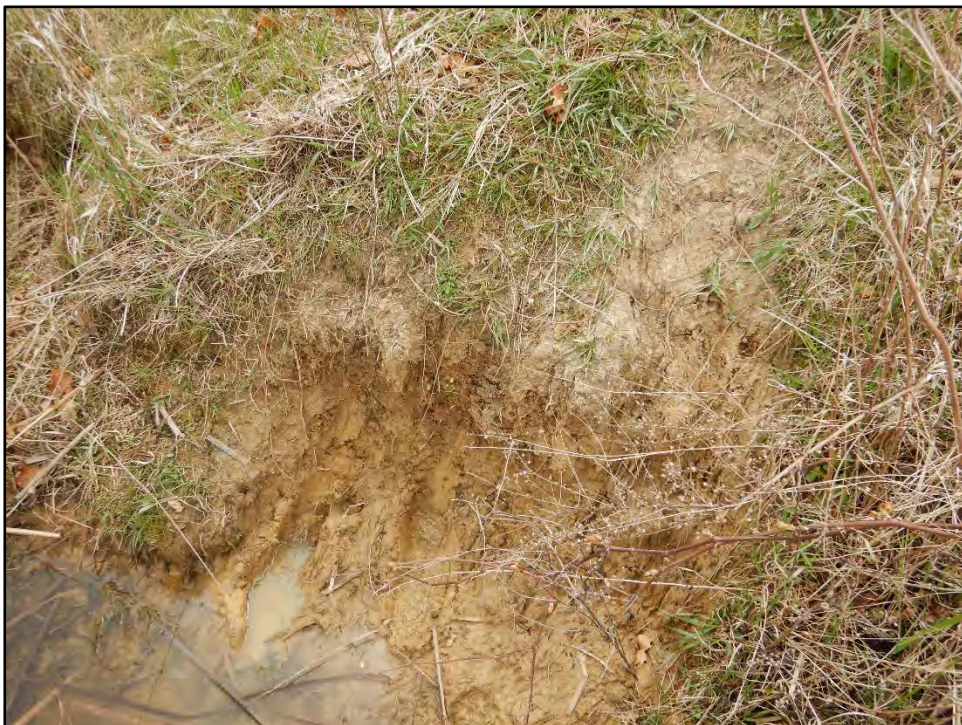
Figure 14: Photo taken on 4/20/21 showing minor erosion at water line.

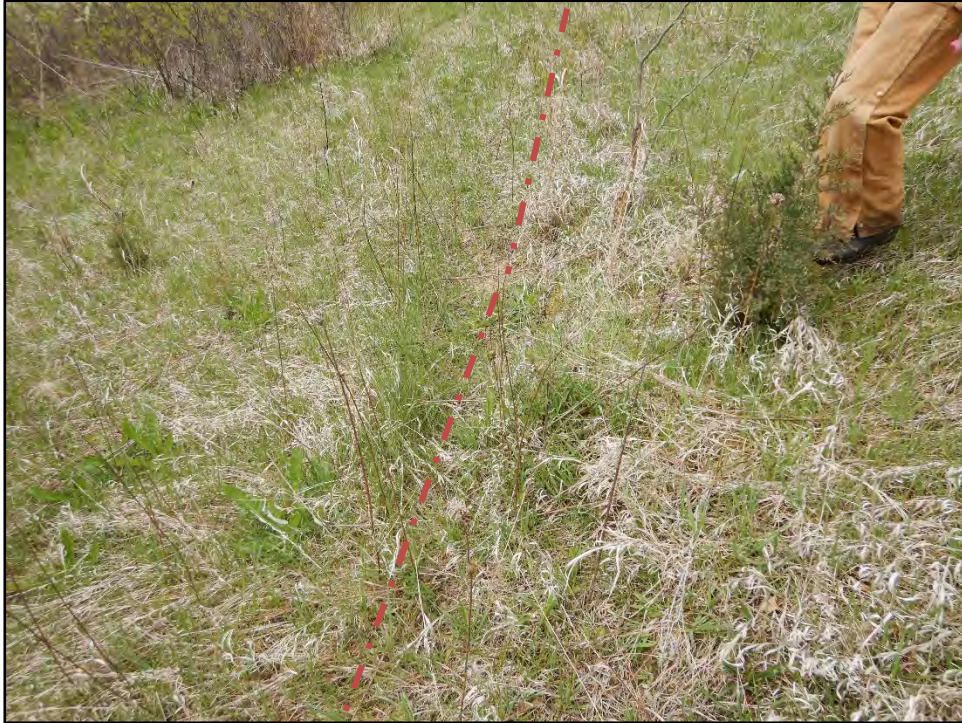
The deficiencies noticed on this structure include trees/brush growing on the embankment and at the waterline. Small animal burrows were present on the embankment. A possible microslide on the upper 2/3rds of the downstream slope was observed (Figure 15 in Appendix). Given the dam's height and steep backslope combined with a wet toe from Big Hollow Lake, conditions suggest a microslide may be forming. The microslide was noticed by a bare patch on the dam embankment parallel to the dam centerline over a noticeable stretch of the dam face which indicates the start of possible sloughing of the downstream slope and could potentially lead to a more significant slide of the downstream embankment face. Figure 5 below shows the progression of a complete slide resulting in much larger failure.

Figure 15: Photo taken on 4/20/21 showing signs of possible microslide on downstream slope signified by small bare grass line approximately 2/3rds up the embankment

Linder Pond recommendations include repairing animal burrows, clearing the embankment of trees/brush, and monitoring/documenting conditions annually for the potential microslide identified.

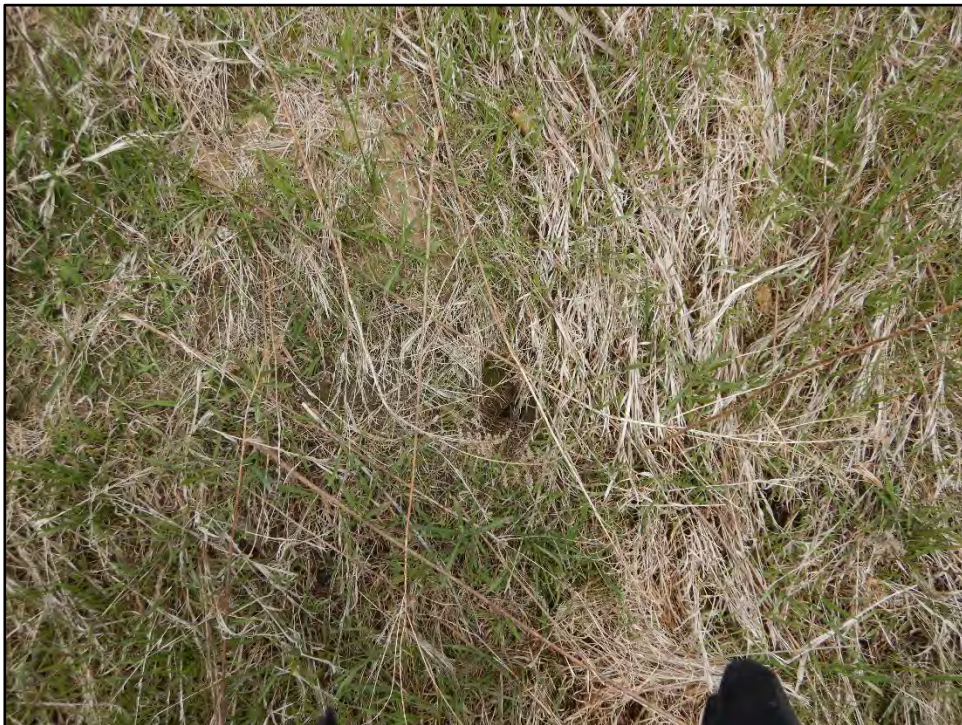
Figure 16: Photo taken on 4/20/21 showing rodent burrow on downstream slope.

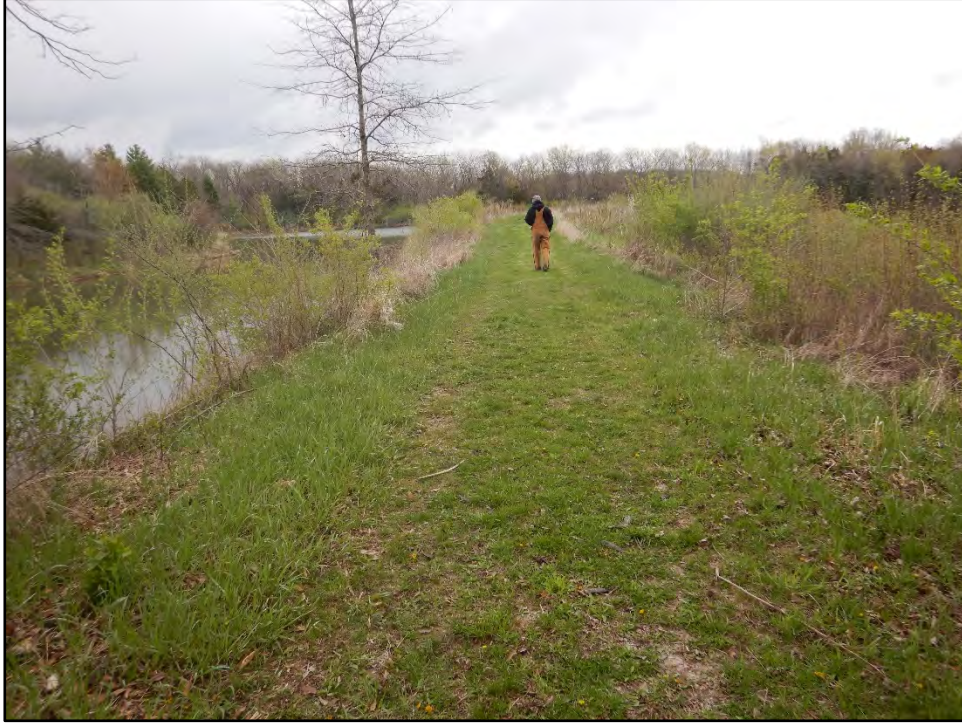
Figure 17: Photo taken on 4/20/21 showing trees and brush growing at water line

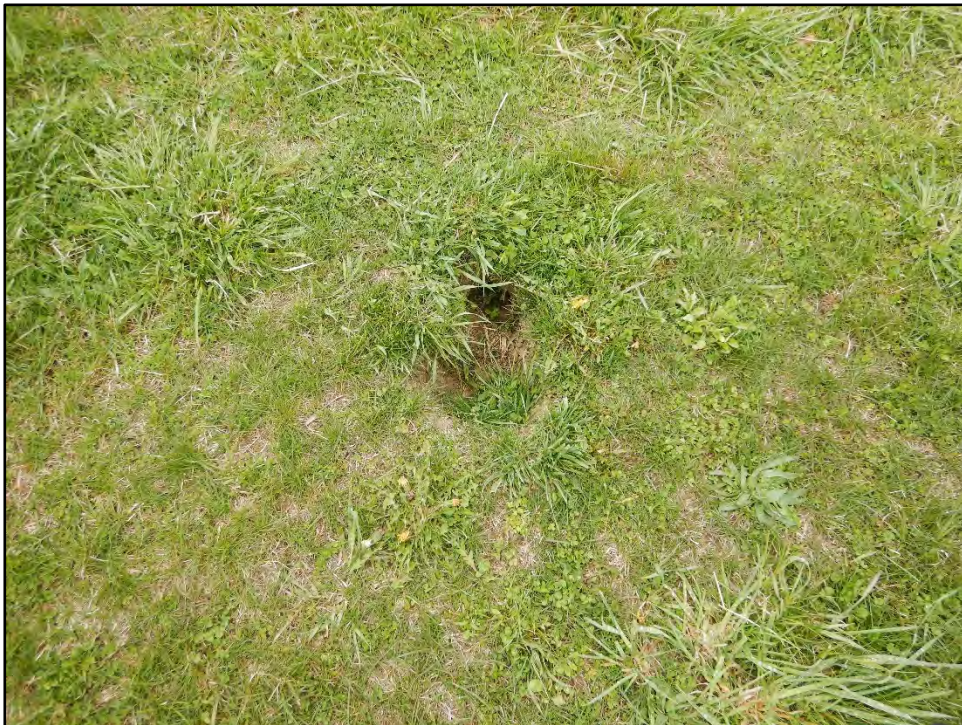
Figure 18: Photo taken on 4/20/21 showing an animal burrow on the dam crest.

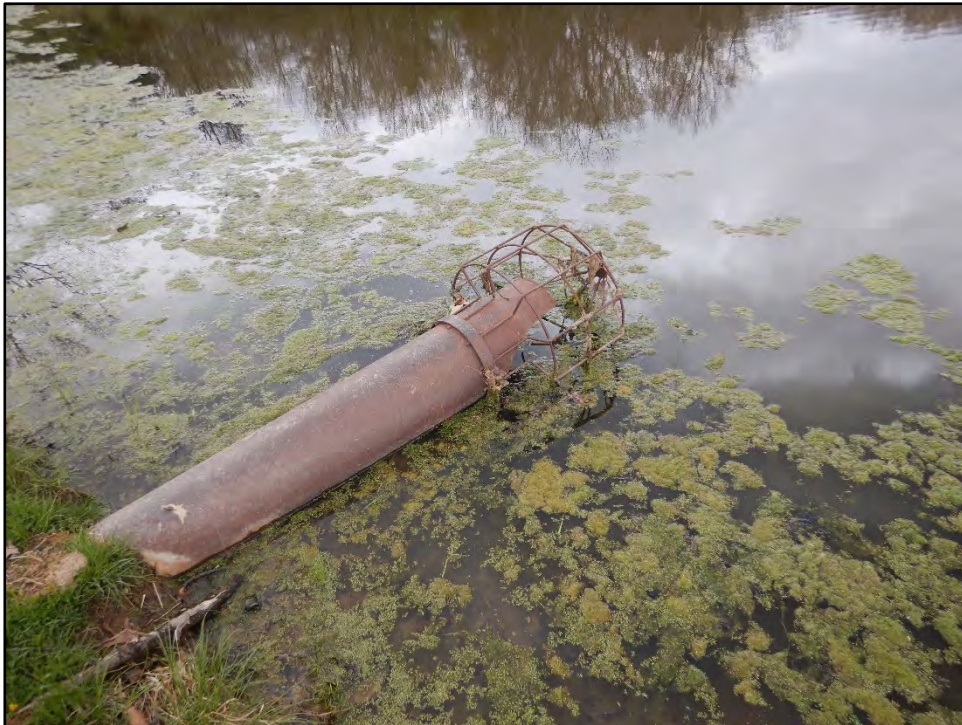
Figure 22: Photo taken on 4/20/21 showing the principal spillway with hooded inlet and rebar trash rack.

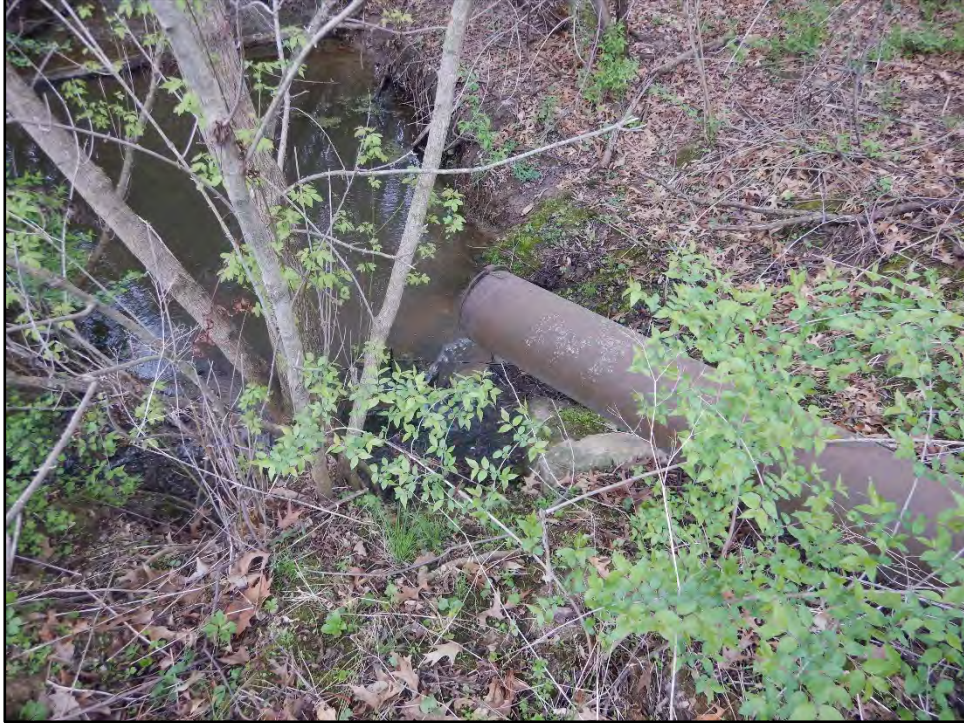
Figure 25: Photo taken on 4/20/21 showing the principal spillway outlet with rodent guard and small scour hole.

Issues observed at Ranger Pond include very minor trees and brush growing on the embankment, moderate erosion along the right groin of the downstream embankment due to local concentrated flow, minor corrosion of the principal spillway conduit, and minor scouring at the outlet of the pipe. These are relatively minor deficiencies, and this dam is expected to perform safely under anticipated conditions. Annual inspections and routine maintenance are recommended.

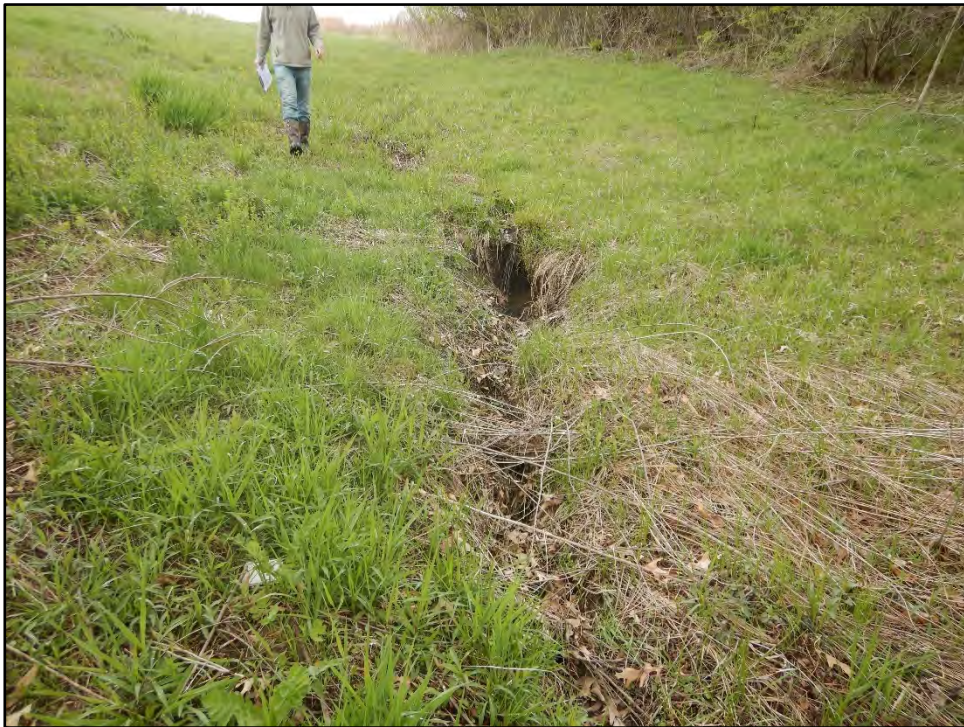
Figure 26: Photo taken on 4/20/21 showing minor erosion from local drainage along the groin of the downstream slope.

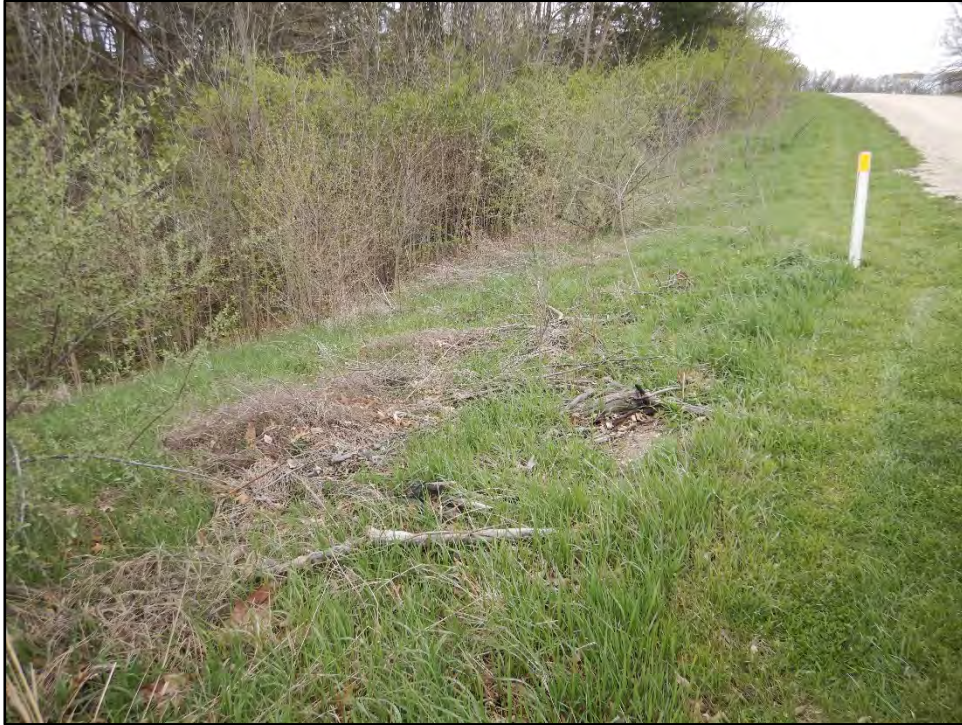
Figure 27: Photo taken on 4/20/21 showing minor trees and brush on the downstream slope of the dam.

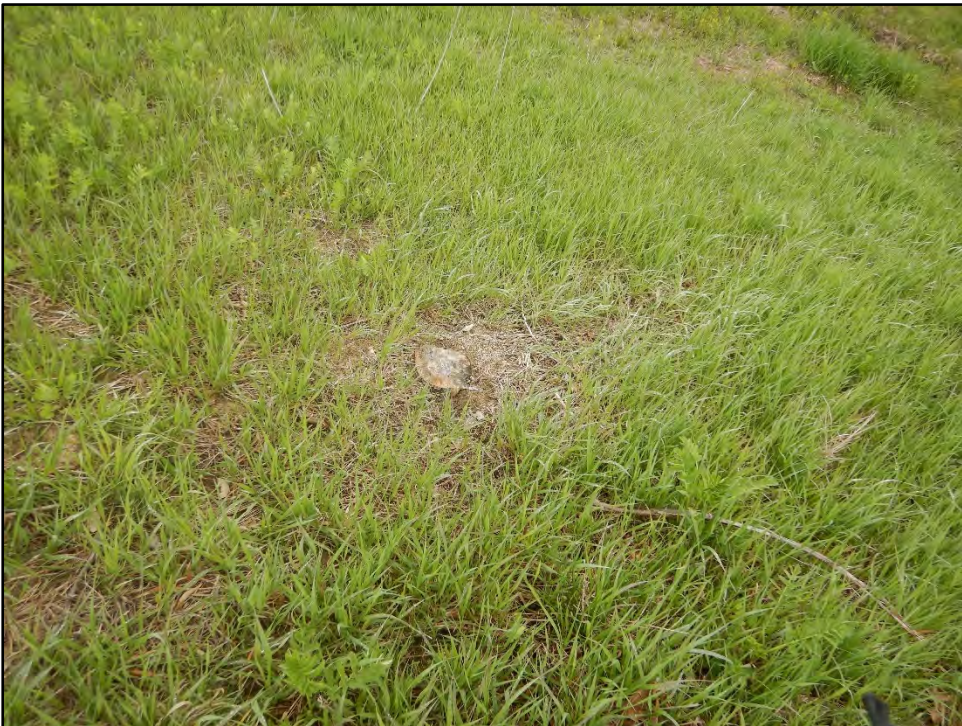
Figure 28: Photo taken on 4/20/21 showing a stump from cut tree on downstream slope of the dam.

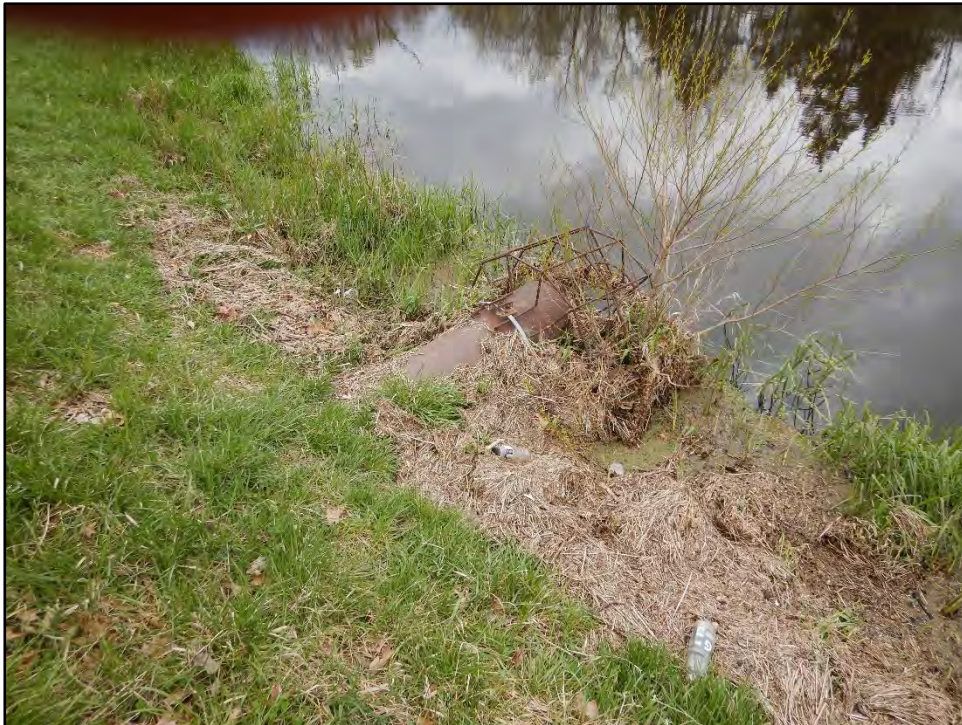
Figure 34: Photo taken on 4/20/21 showing the 18" diameter steel principal spillway inlet pipe with rebar trash rack and minor brush growing around inlet.

Minor maintenance recommendations include clearing any trees and brush from the embankment and making sure the trash rack is clear of any obstructions at the inlet of principal spillway pipe. Continue to monitor the small microslide on the downstream side of the embankment and monitor the water level in the pond while checking the embankment for any wet spots where a leak may be present.

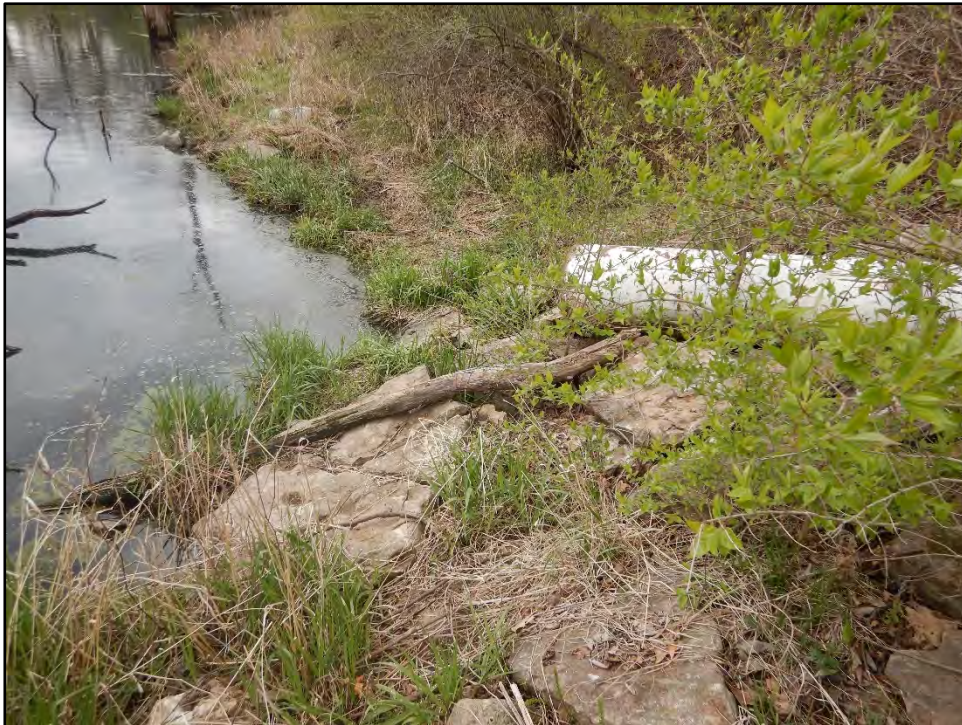
Chris Lee mentioned this pond was fully rehabilitated approximately eight years prior (2012/2013). The pond was drained and a new embankment and spillway pipe were constructed. A bentonite seal was used to help prevent prior/documented leaking. Chris mentioned the pond still leaks even after the rehabilitation. Shoreline protection rock on the downstream end was placed when the lake was formed and serves as outlet protection for the spillway pipe.

Figure 36: Photo taken on 4/20/21 showing the principal spillway outlet with rock riprap outlet and shoreline protection.

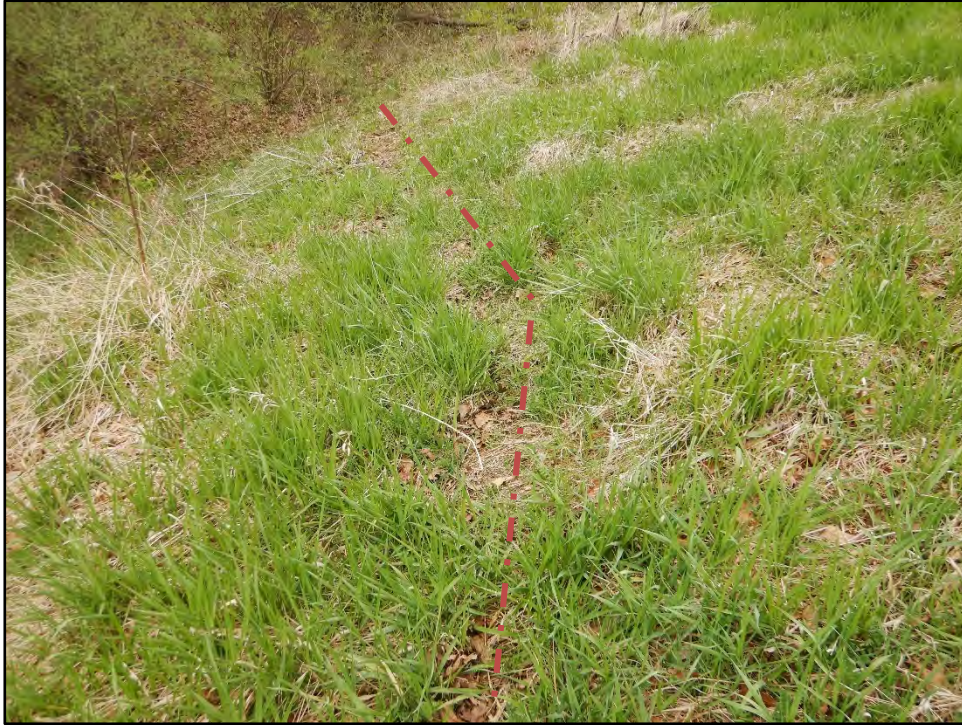
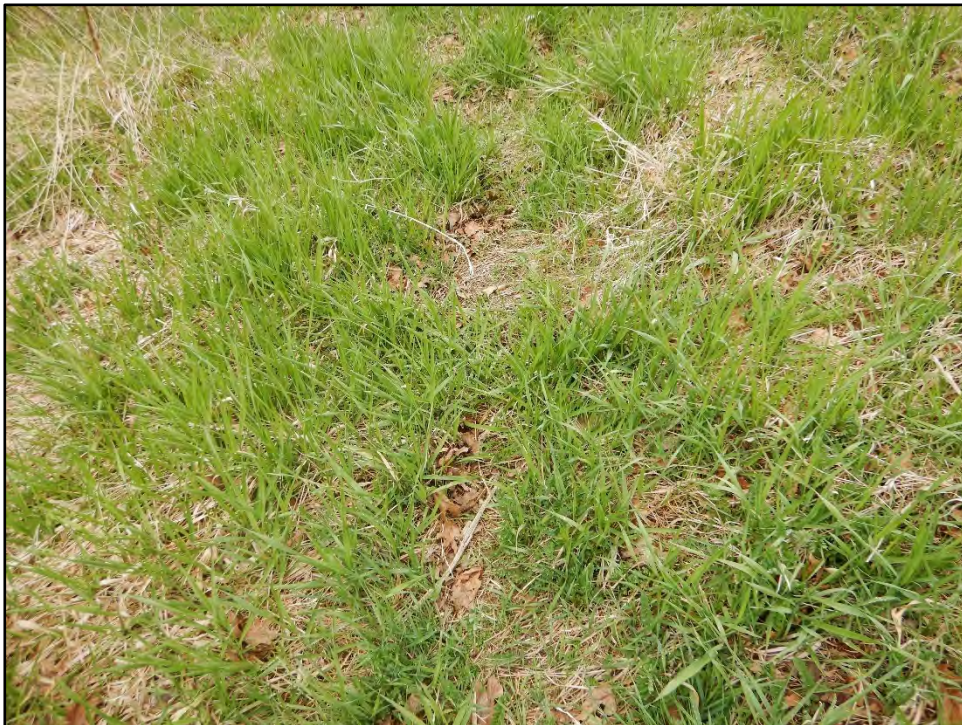
The inspection revealed the pond is maintaining its water level with no evident seeps or holes in the embankment. There was a small microslide on the downstream embankment signified by bare line across the upper 2/3rds of the embankment (Figure 37 in Appendix).

Figure 37: Photo taken on 4/20/21 showing possible microslide signified by line of bare earth 2/3rds up the downstream slope of the dam.

Figure 38: Photo taken on 4/20/21 showing possible microslide signified by line of bare earth 2/3rds up the downstream slope of the dam.
