Final Big Hollow Watershed Management Plan Des Moines County, Iowa

18 April 2022

Re: Dam Inspection Findings and Recommendations

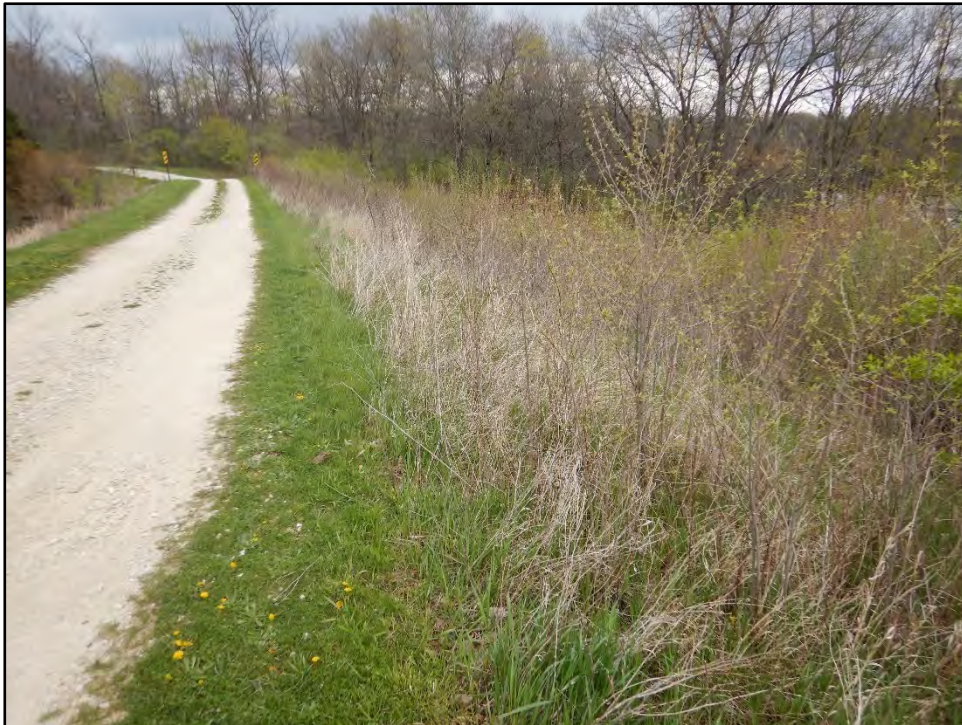
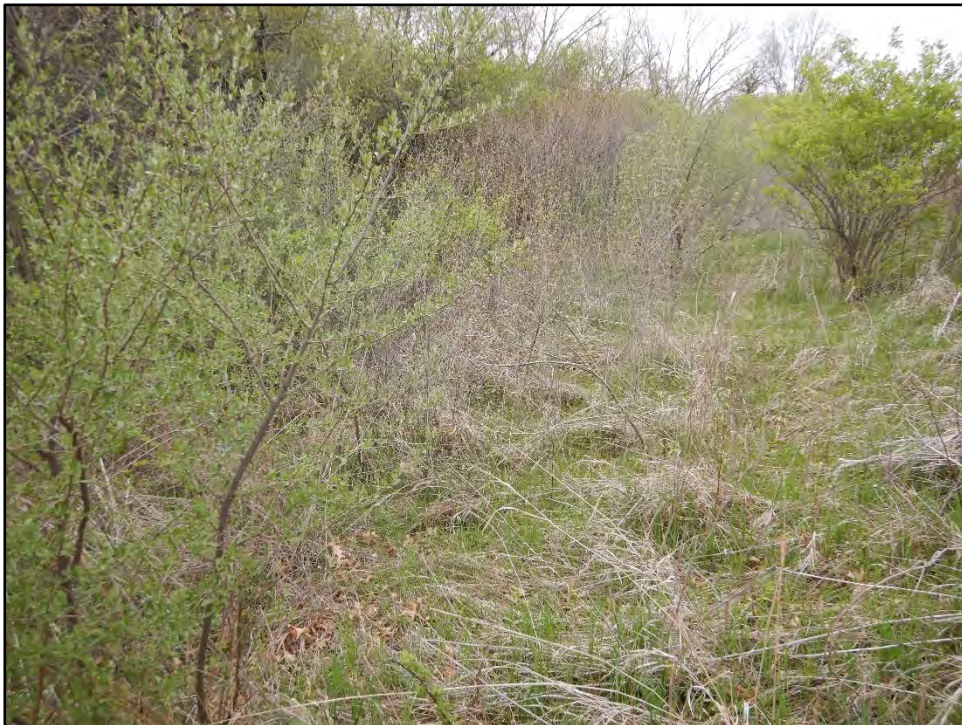
The structure seemed to be in satisfactory condition and no serious deficiencies were noted. There are a few minor issues, including large amounts of brush growing on the downstream slope (Figure 42 in Appendix), minor corrosion of the spillway pipe, and small scouring at the outlet.

Figure 42: Photo taken on 4/20/21 showing the large amounts of trees and brush growing on downstream slope of the dam.

Figure 46: Photo taken on 4/20/21 showing the large amount of brush on the downstream slope of the dam.

The principal spillway pipe inlet should be repaired to maintain hydraulic capacity. To prevent future damage with any maintenance equipment, make sure the area around the pipe is clear of brush and tall vegetation. This will also help with better conveyance of water through the pipe. Rock rip rap can also be added at the outlet for erosion control and to prevent any future scouring. Lastly, clear the large amounts

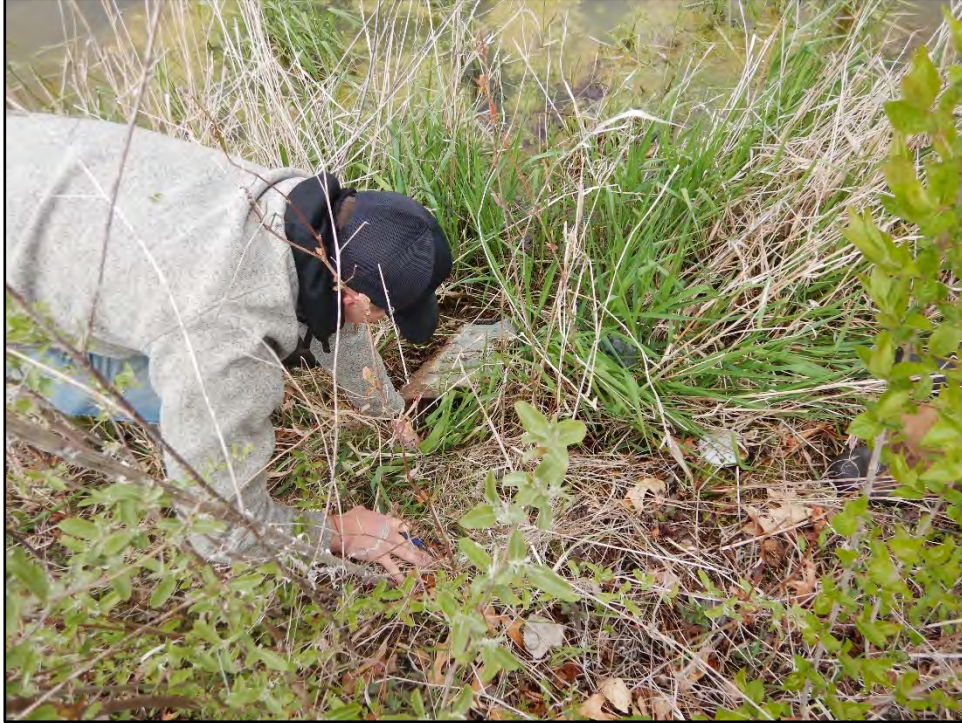
Figure 43: Photo taken on 4/20/21 showing the principal spillway inlet with brush growing around the inlet.

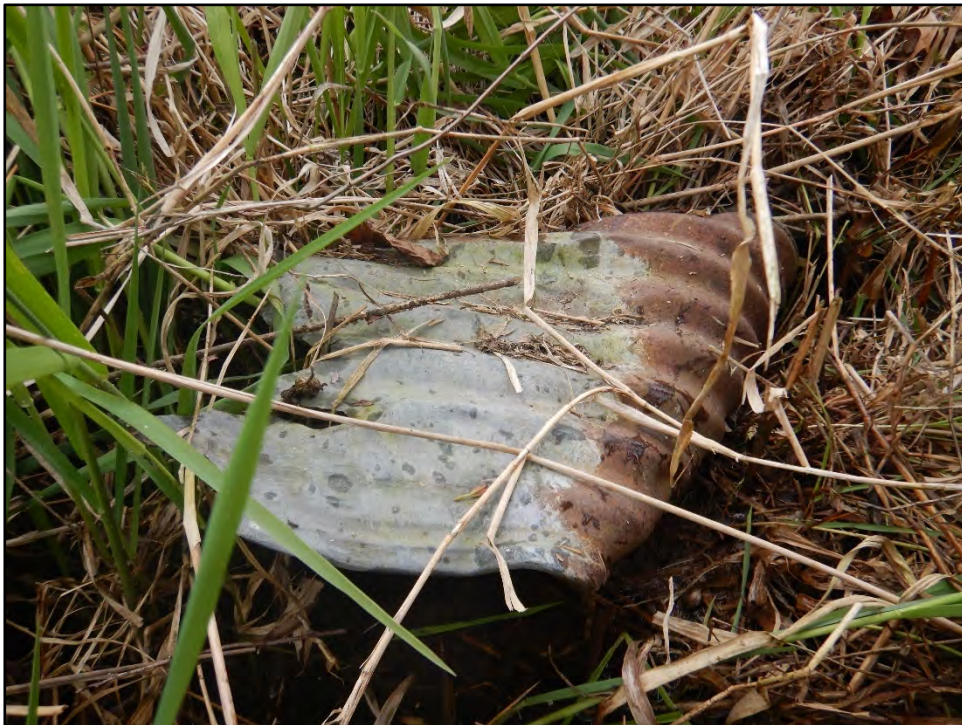
No Name Pond 1 is part of the park road on the east side of the park (Site 5 in Figure 1). The principal spillway on this structure consists of a 6" diameter CMP straight pipe with no trash rack. The inlet on this structure is slightly damaged and bent (Figure 44 in Appendix), and there was no auxiliary spillway on this structure.

Figure 44: Photo taken on 4/20/21 showing the bent 6" CMP principal spillway inlet.

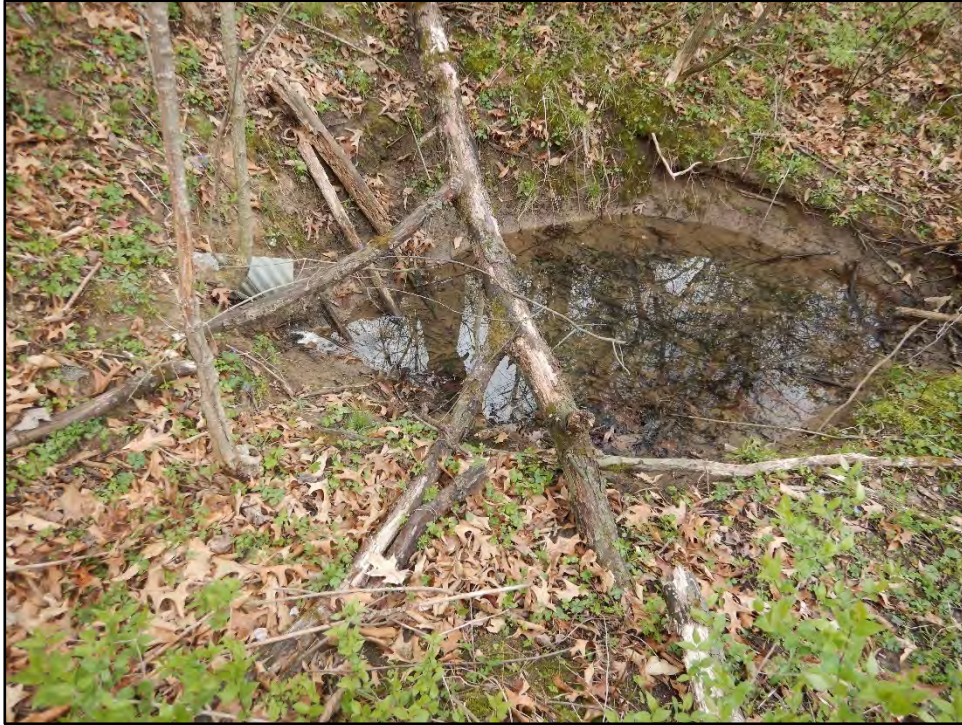
Figure 45: Photo taken on 4/20/21 showing 6" CMP principal spillway outlet with small scour hole.

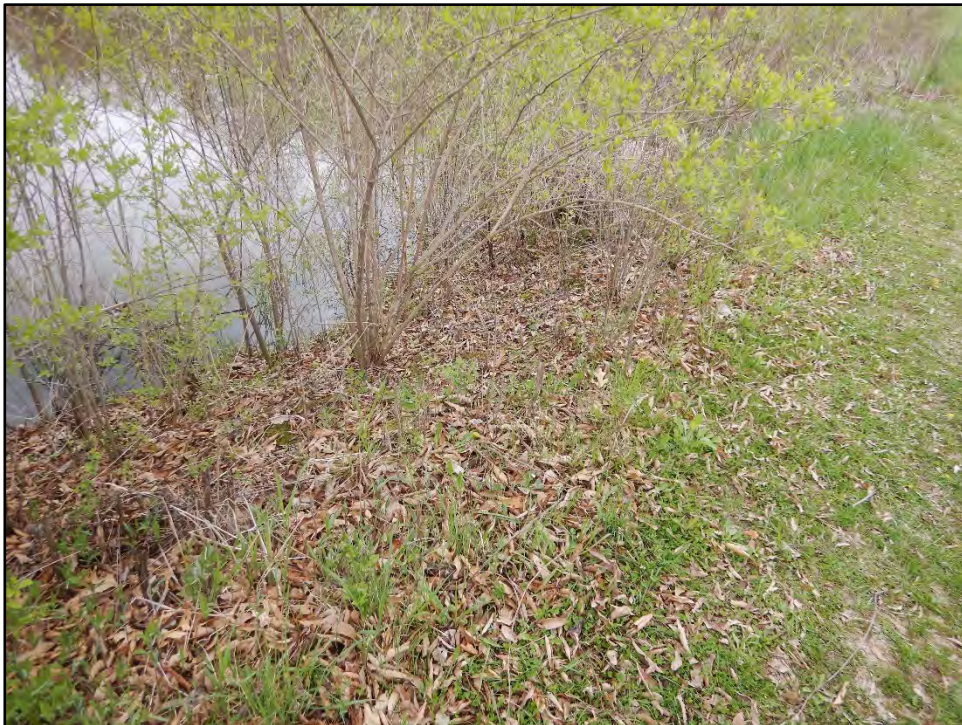
Figure 48: Photo taken on 4/20/21 showing the upstream slope and a few trees and brush growing at the water line.

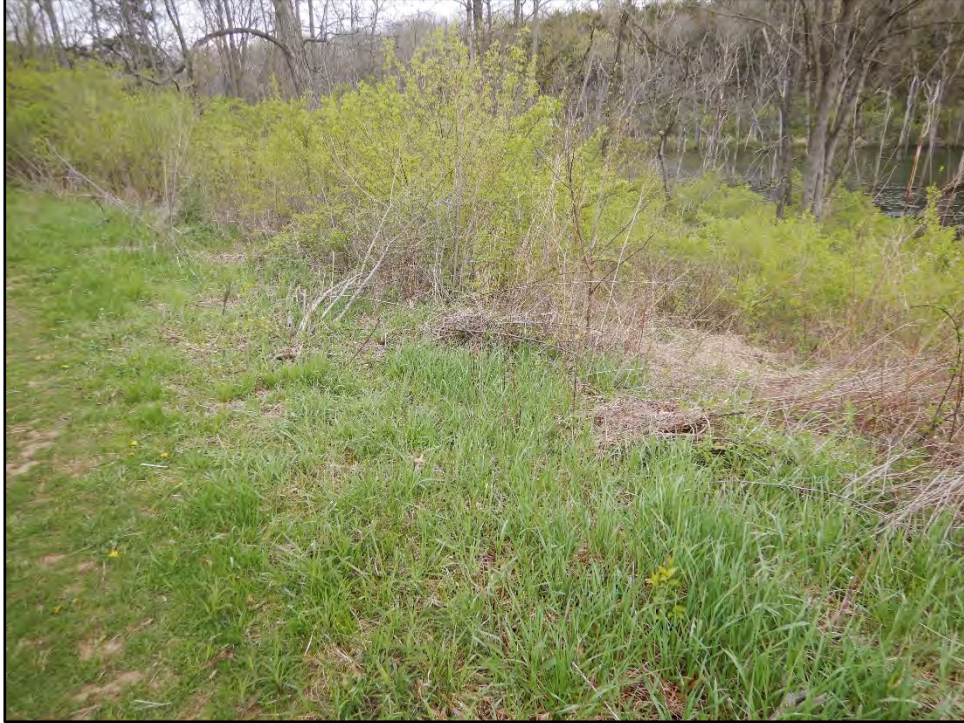
Figure 49: Photo taken on 4/20/21 showing large amounts of trees and brush on the downstream slope of the dam.

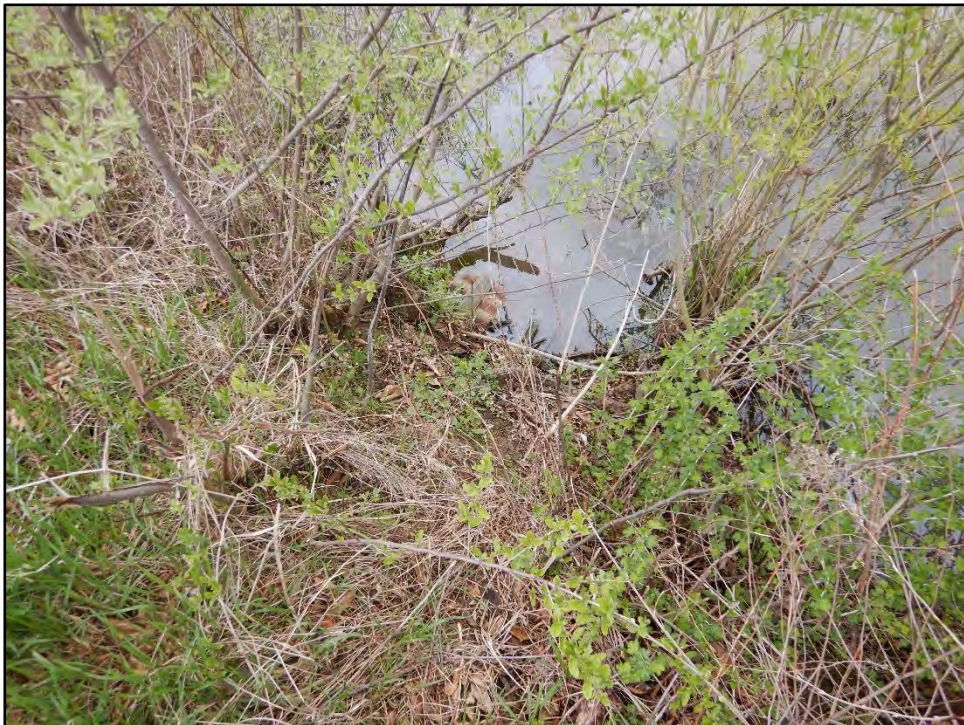
Figure 50: Photo taken on 4/20/21 showing the 6" CMP with hooded inlet.

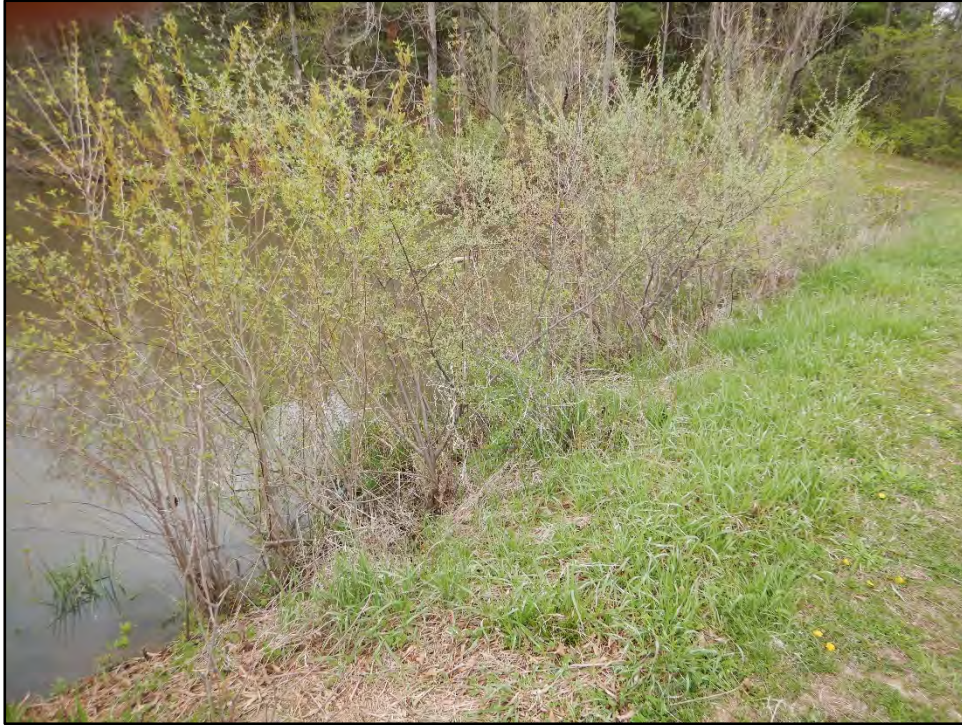
Figure 51: Photo taken on 4/20/21 showing some trees and brush growing at the water line on the upstream slope.

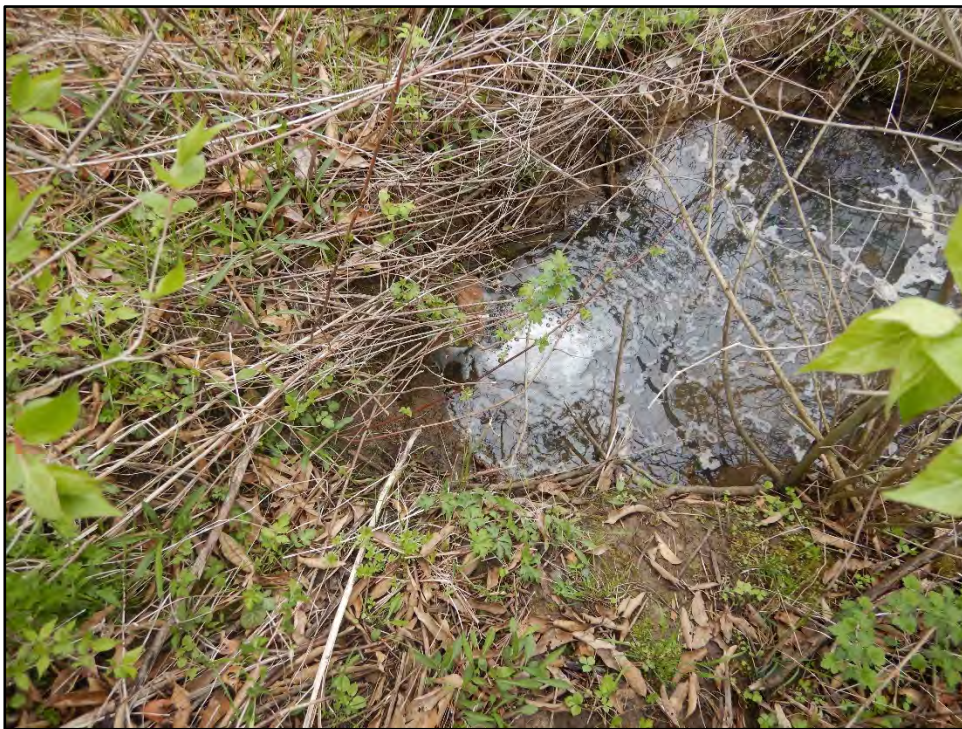
Figure 52: Photo taken on 4/20/21 the 6" CMP outlet with minor scour hole.
