Templar Park Resource Management Area (RMA)

MARBLE/ HOTTES LAKES WATERSHED

LITTLE SPIRIT LAKE WATERSHED

LOON LAKE WATERSHED

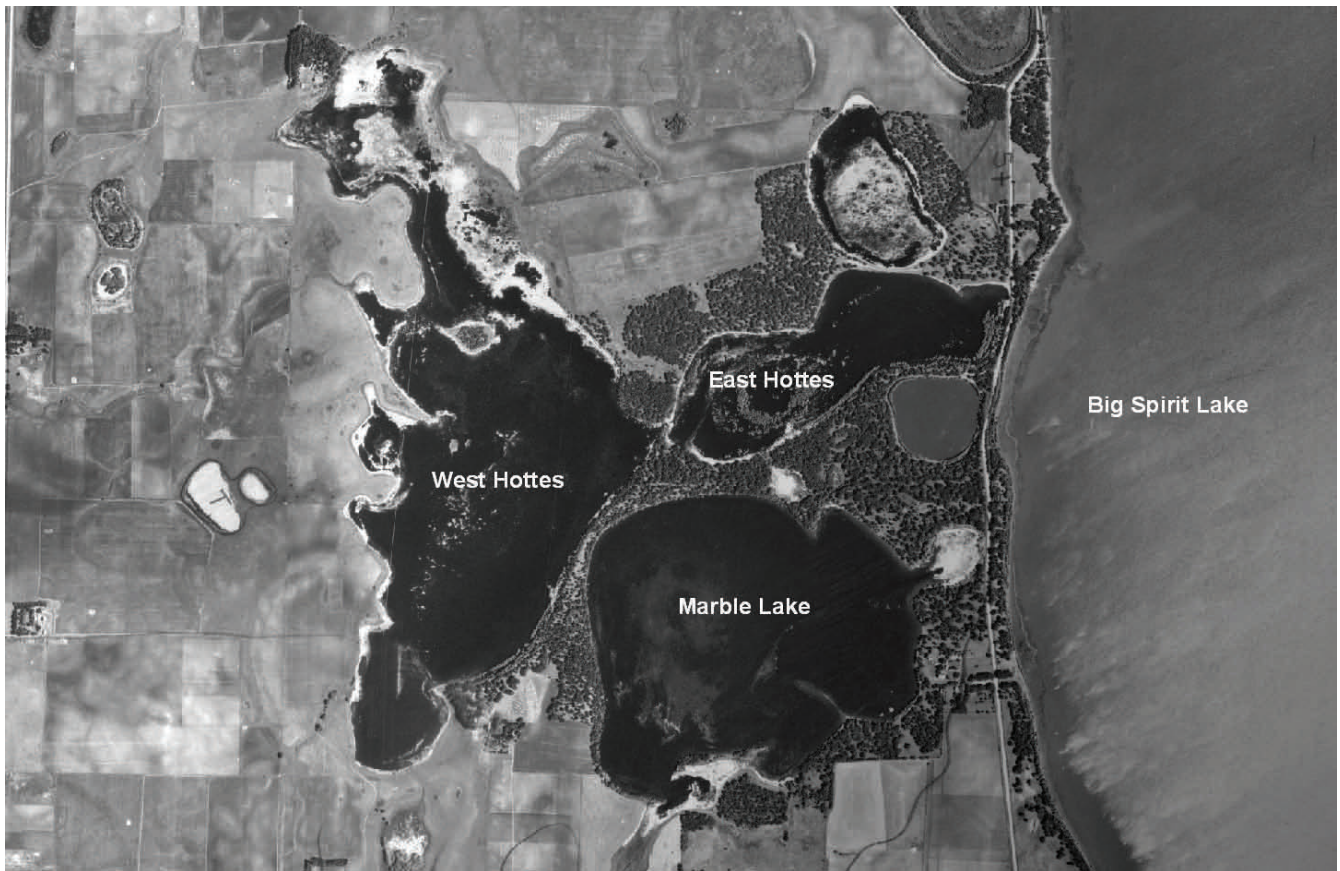
Figure 1.73 MARBLE AND HOTTES LAKE Aerial Photography from 1939 (top) and 2002 (bottom) demonstrating the change in extent of emergent vegetation

Description – Major changes in hydrology in the watersheds of this complex, along with the introduction of common carp have led to slow degradation of water quality in these shallow lakes. Aquatic vegetation has nearly disappeared in Marble Lake and has receded dramatically in West Hottes Lake. As the 1939 and 2002 aerial photos show a considerable amount of vegetation has disappeared on the Hottes/Marble Lake Complex (Figure 1.73 and 1.74) The Hottes/Marble Lake Resource Management Area is shown in Figure 1.37.
