Otter Creek Lake Watershed Plan

The development of the Otter Creek Lake Watershed Management Plan was a cooperative effort among:

Plan Revised January 22, 2020

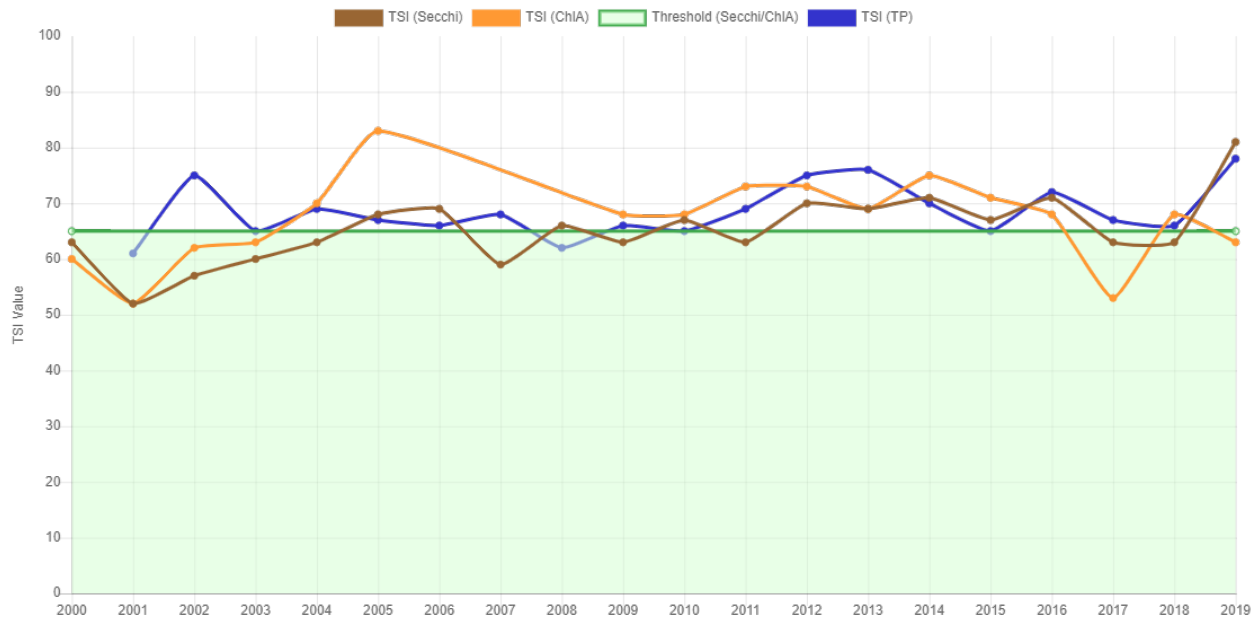
The chart below further illustrates the Trophic State Index values over time compared to the Iowa Impairment Trigger Level.

Figure 12. TSI values, 2000 - 2019 (Source: AQUIA Database)

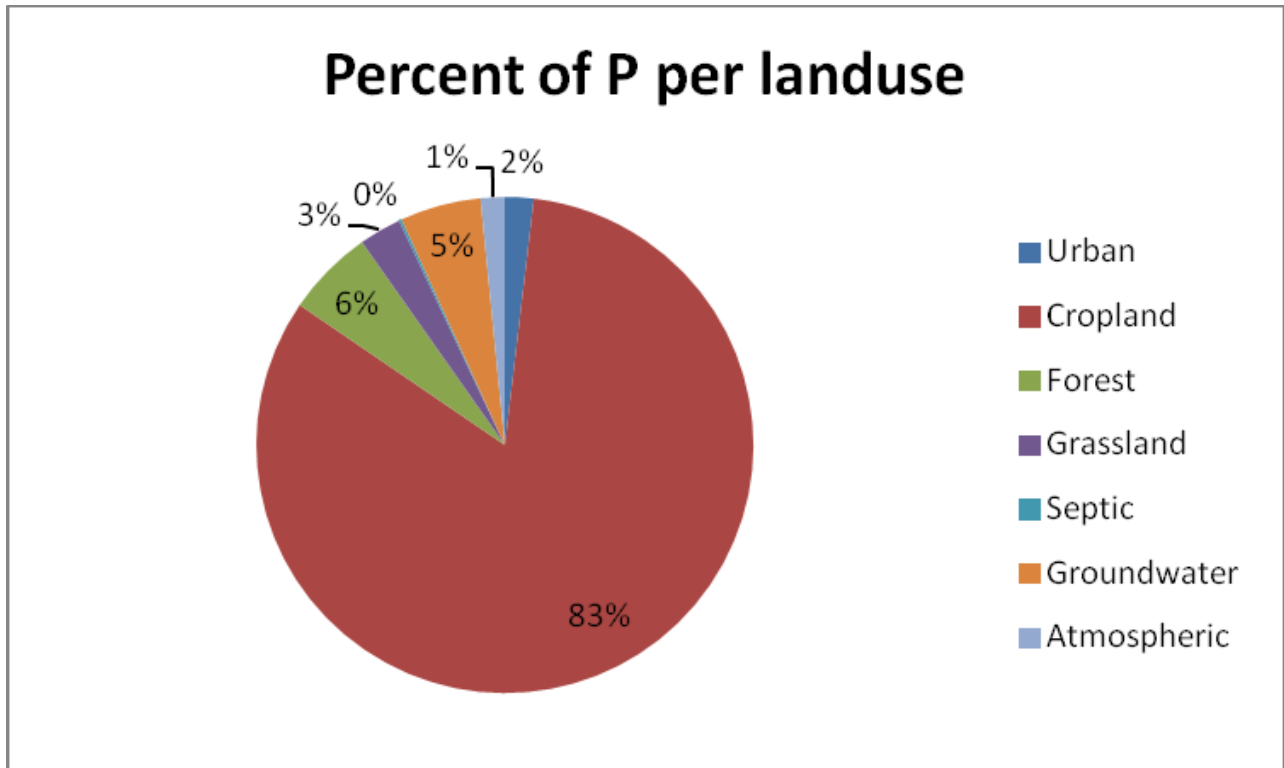
The following chart breaks down the percentage of phosphorus entering the lake from each land use.

Figure 13. Percentage of the TP load per land use (Source: Otter Creek Lake 2014 Water Quality Improvement Plan).

Existing TP Load: 1,497 lbs/yr
 External: 1205 lbs/yr
 Internal: 292 lbs/yr

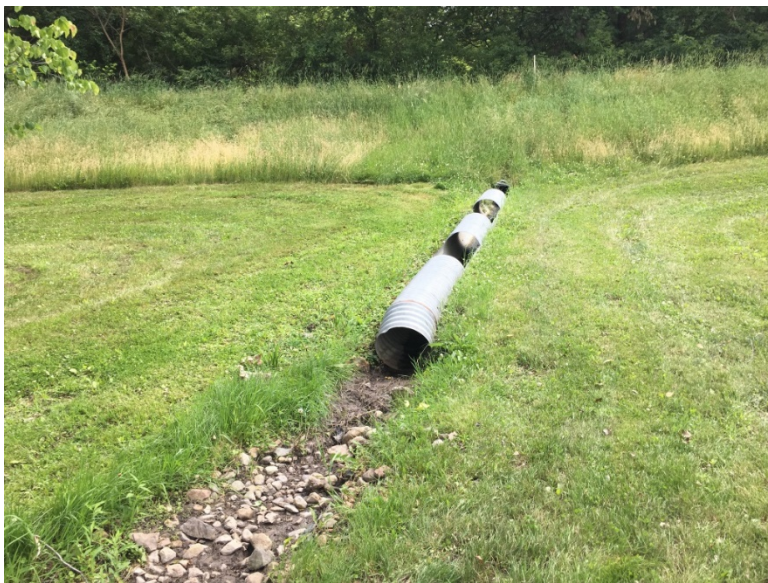
Figure 1 – Culvert draining to the north of the beach.

- Use spoil from dredging activities to raise up the lawn area to reduce ponding and redirect runoff towards the existing waterway
- Improve the waterway, and repair culvert, possibly utilizing a bioswale with native vegetation (or other method to infiltrate / slow the flow through the waterway)
- Investigate the potential for a wetland or rain garden / bioretention cell feature to capture the flow / associated sediments from the existing waterway
- Investigate the potential of improving the parking area, either through permeable paving or incorporating stormwater practices such as rain gardens / bioretention cells to reduce runoff from the parking area
- Investigate the possibility for a sloped beach area
- Opportunity to incorporate Item #12 from wish list (re-route road near beach)

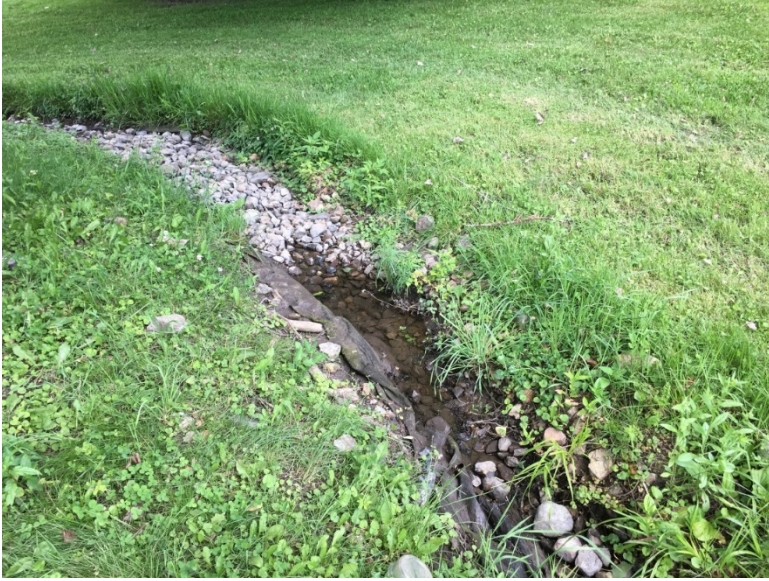
Figure 2. Poor condition of waterway / ditch draining along north side of beach.

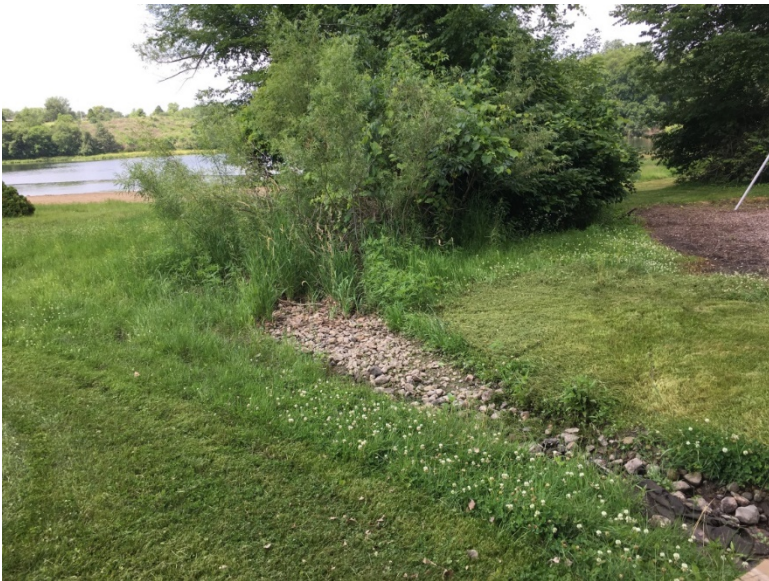
Figure 3. Outlet of the ditch along beach. This area could be repurposed to a wetland or LID feature to better treat water and improve drainage of this area.

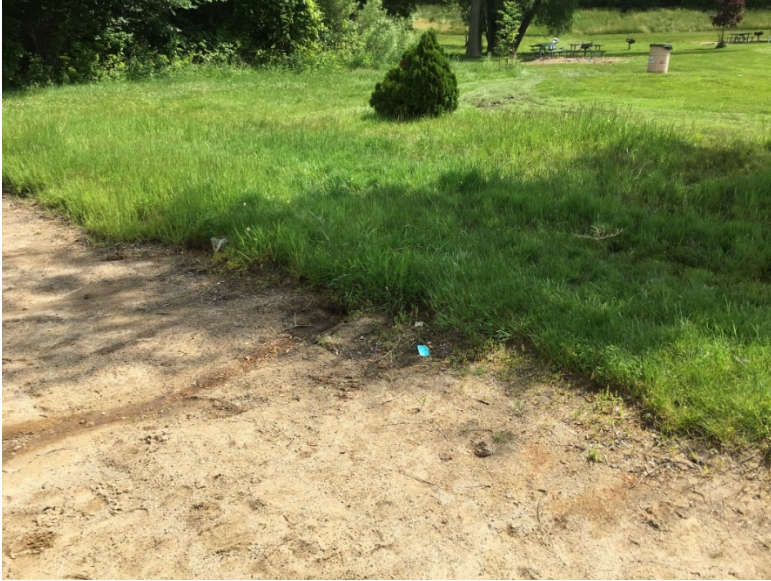
Around the beach, there are numerous issues with drainage / overland flow leading to ponding in some areas. Runoff from the lawn area is leading to concentrated flow running over some places on the beach. An existing waterway conveys drainage, but the culvert is in disrepair and the channel below it is also experiencing some erosion and may contribute sediment loading to the lake. Possibilities for improvement at this site include:

Figure 4. Example of runoff to beach

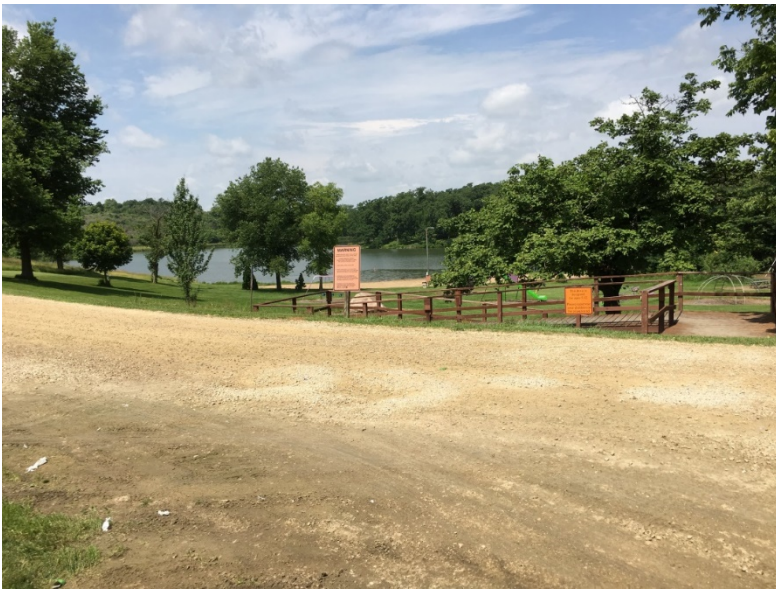
Figure 5. The beach / playground are down slope from the parking area.

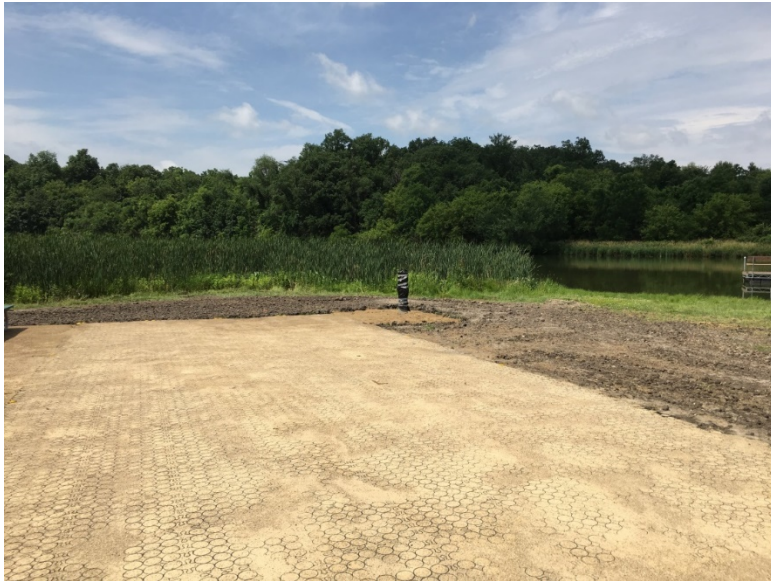
The CCB would like to do cattail mitigation in this area to open up the water for better access to fishing.

Figure 6. Example of an area where the CCB would like to reduce cattails.

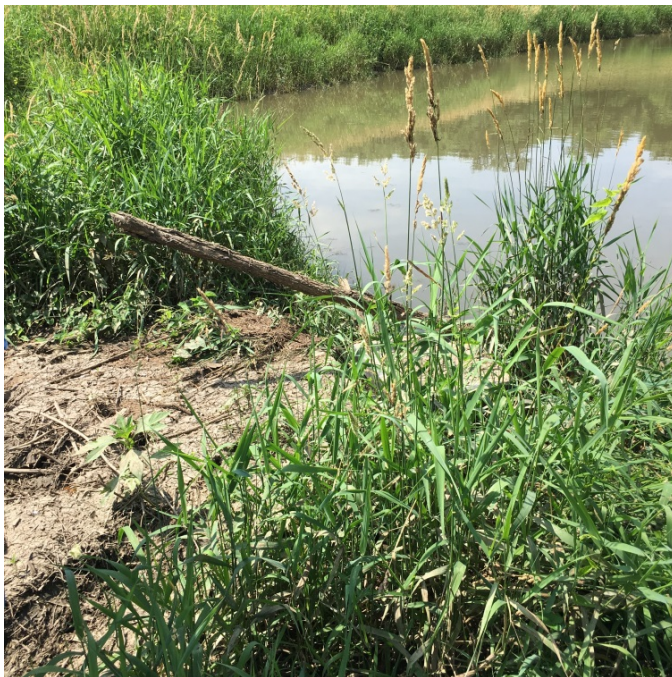
Figure 7. Broken culvert at outlet of silt pond.

Renovation of the existing silt pond would enable additional sediment trapping. The outlet of the pond has a broken culvert that needs to be repaired (?). This area also has potential for spoil storage. An additional structure above the existing ponds could also be possible for enhanced treatment.

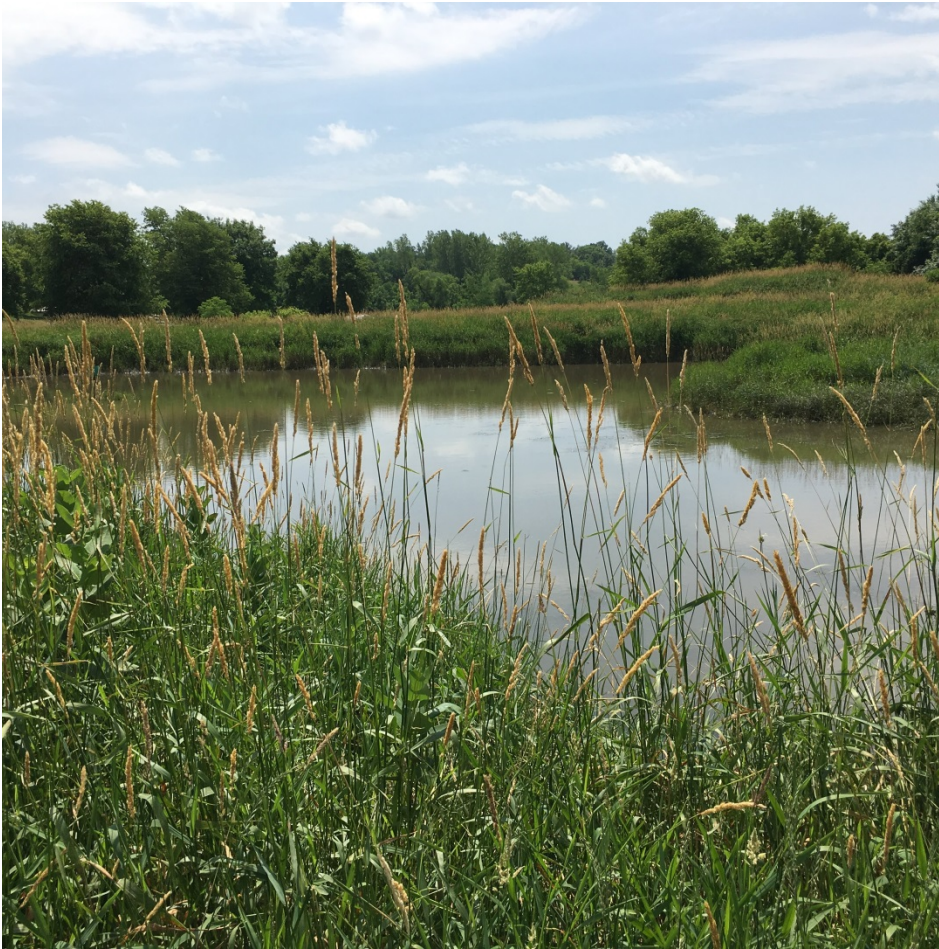
Figure 8. North silt pond, in need of renovation.
