3 Mile Lake Watershed Assessment Plan

Project Agreement #: 17-01

September 18, 2018

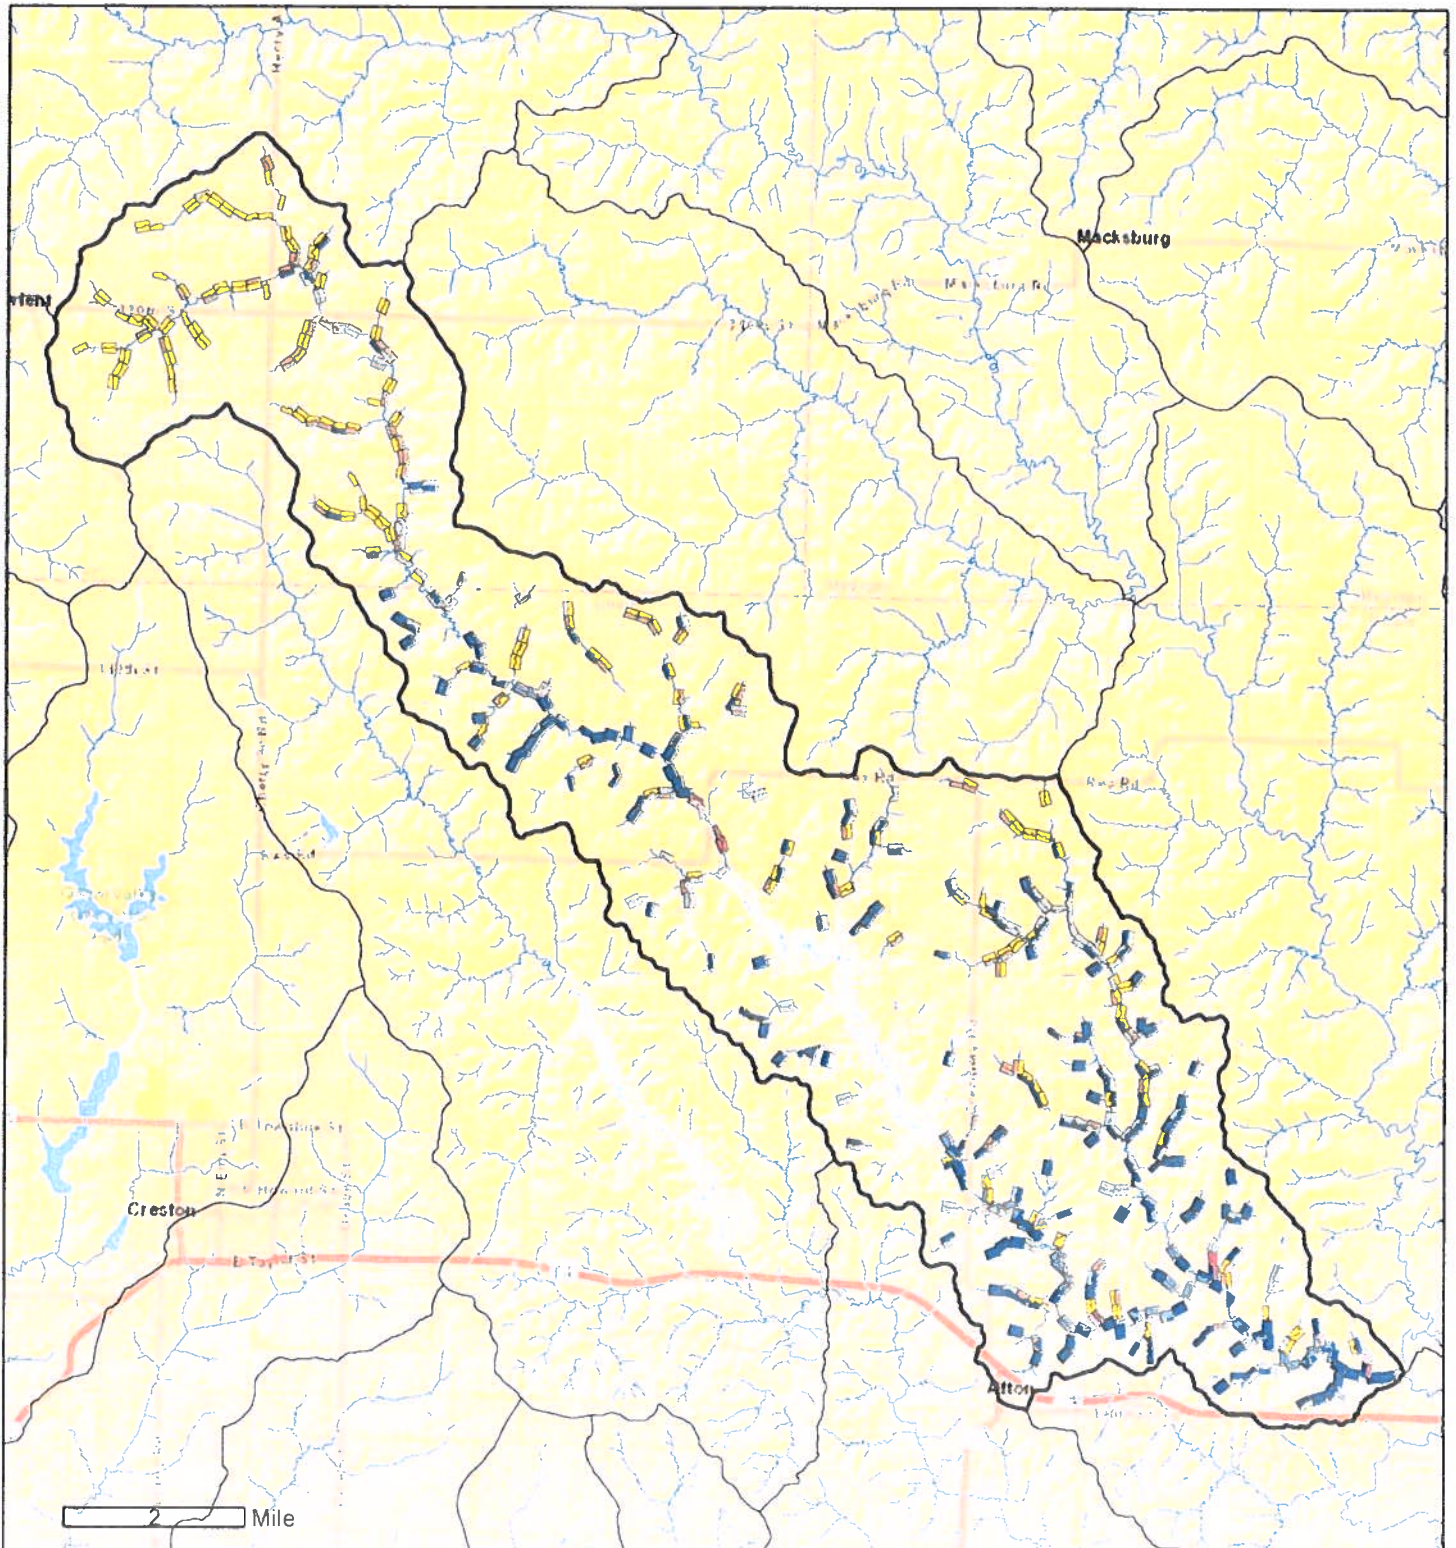
Riparian Saturated Buffer - Suitability/Failure Class

- Suitable for saturated buffers
- Suitable with carbon enhancement
- LandUse
- Topography
- Soils
- Soils/Topography
- SteepBanks
- SteepBanks/Soils
- SteepBanks/Topography
- SteepBanks/Soils/Topography

A map identifying suitable areas for saturated buffers was prepared using data from the Agriculture Conservation Planning Framework.
