#12 Tank House

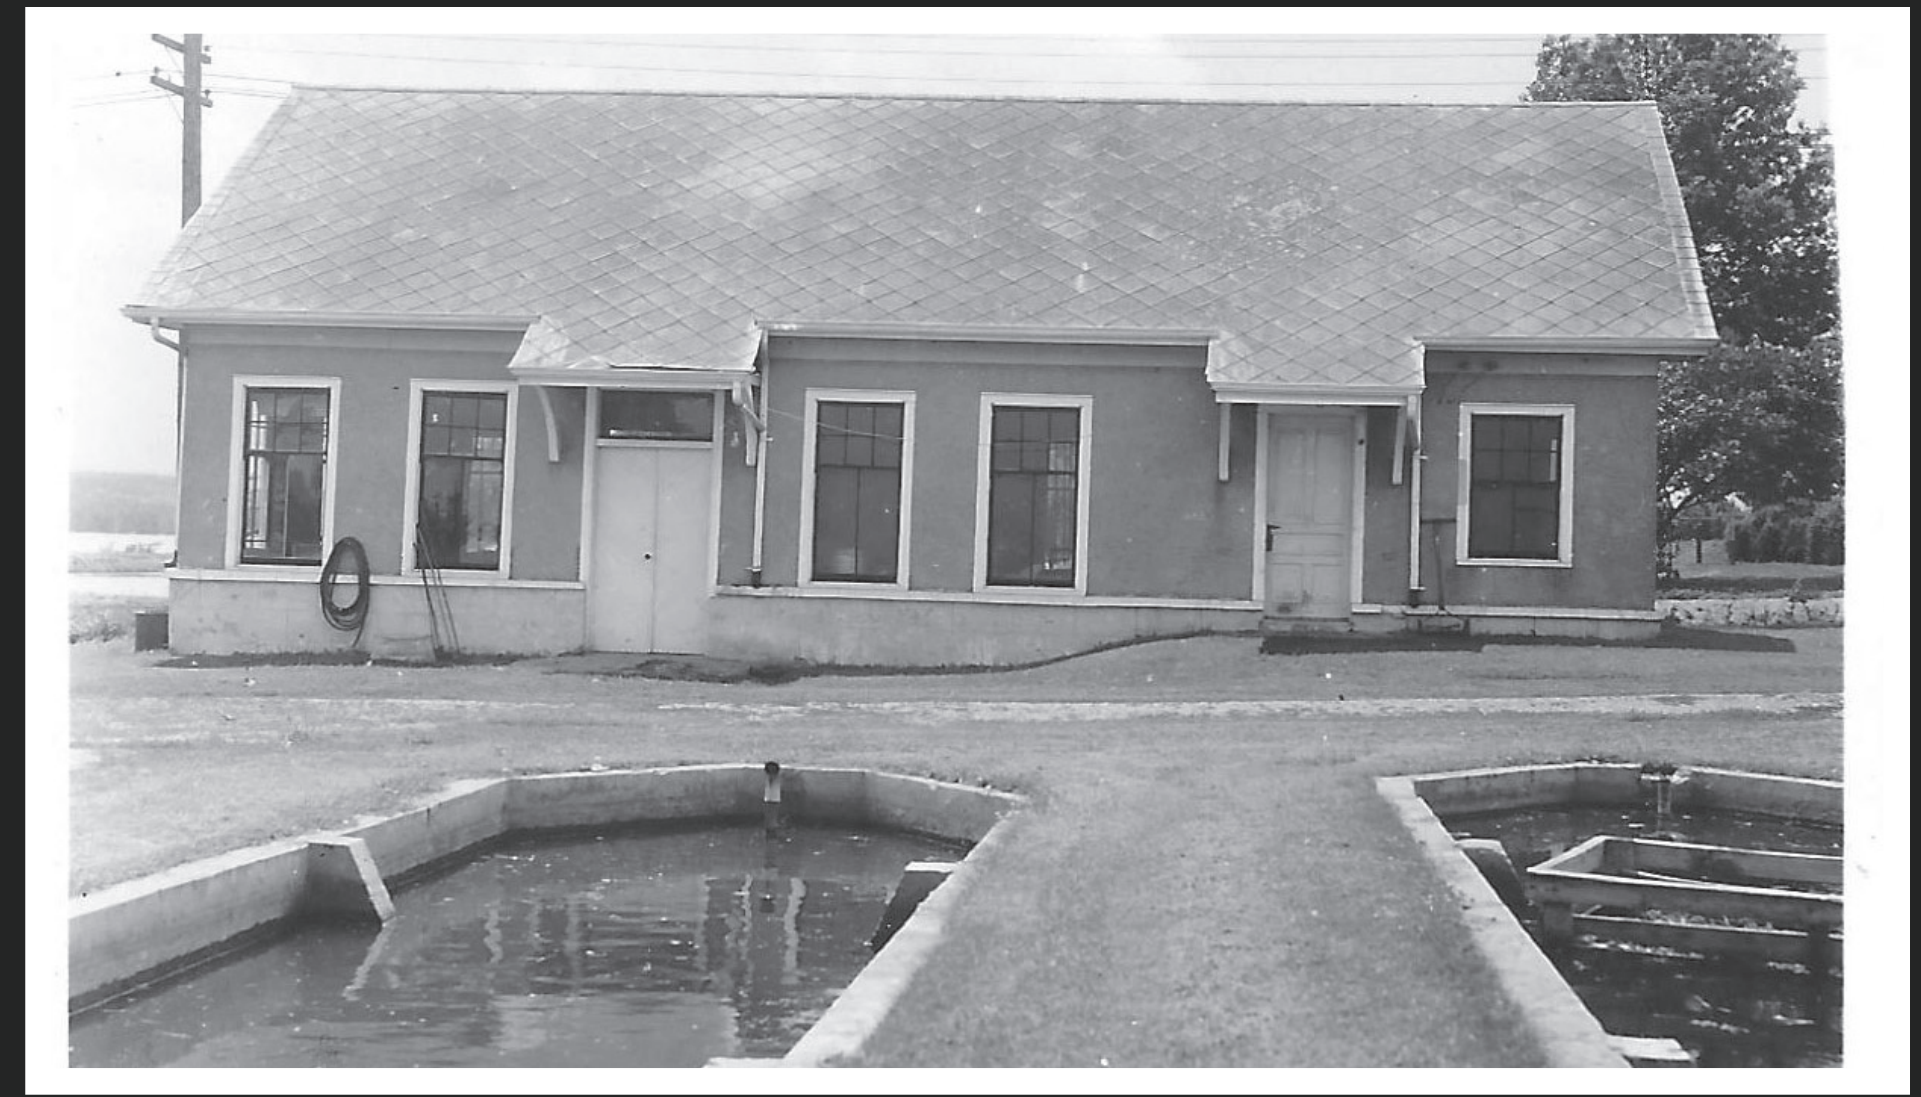
Overview of the Tank House in 1941 with fish/mussel troughs in foreground, facing west.

The original function of the Tank House was for mussel and fish research. The Tank House consisted of a 1-story, wood frame building with a gable roof, composite shingle roof, and pebble dash stucco exterior. The interior had two small offices and six mussel/fish troughs (concrete and metal) of different sizes and depths. There were also six concrete exterior troughs or ponds used for mussel propagation. In 1931 an additional seven galvanized troughs were installed outside the building. The 1941 inventory report refers to this building as the "holding house." The report notes there were six interior troughs (4 metal and 2 concrete) and 16 exterior troughs.

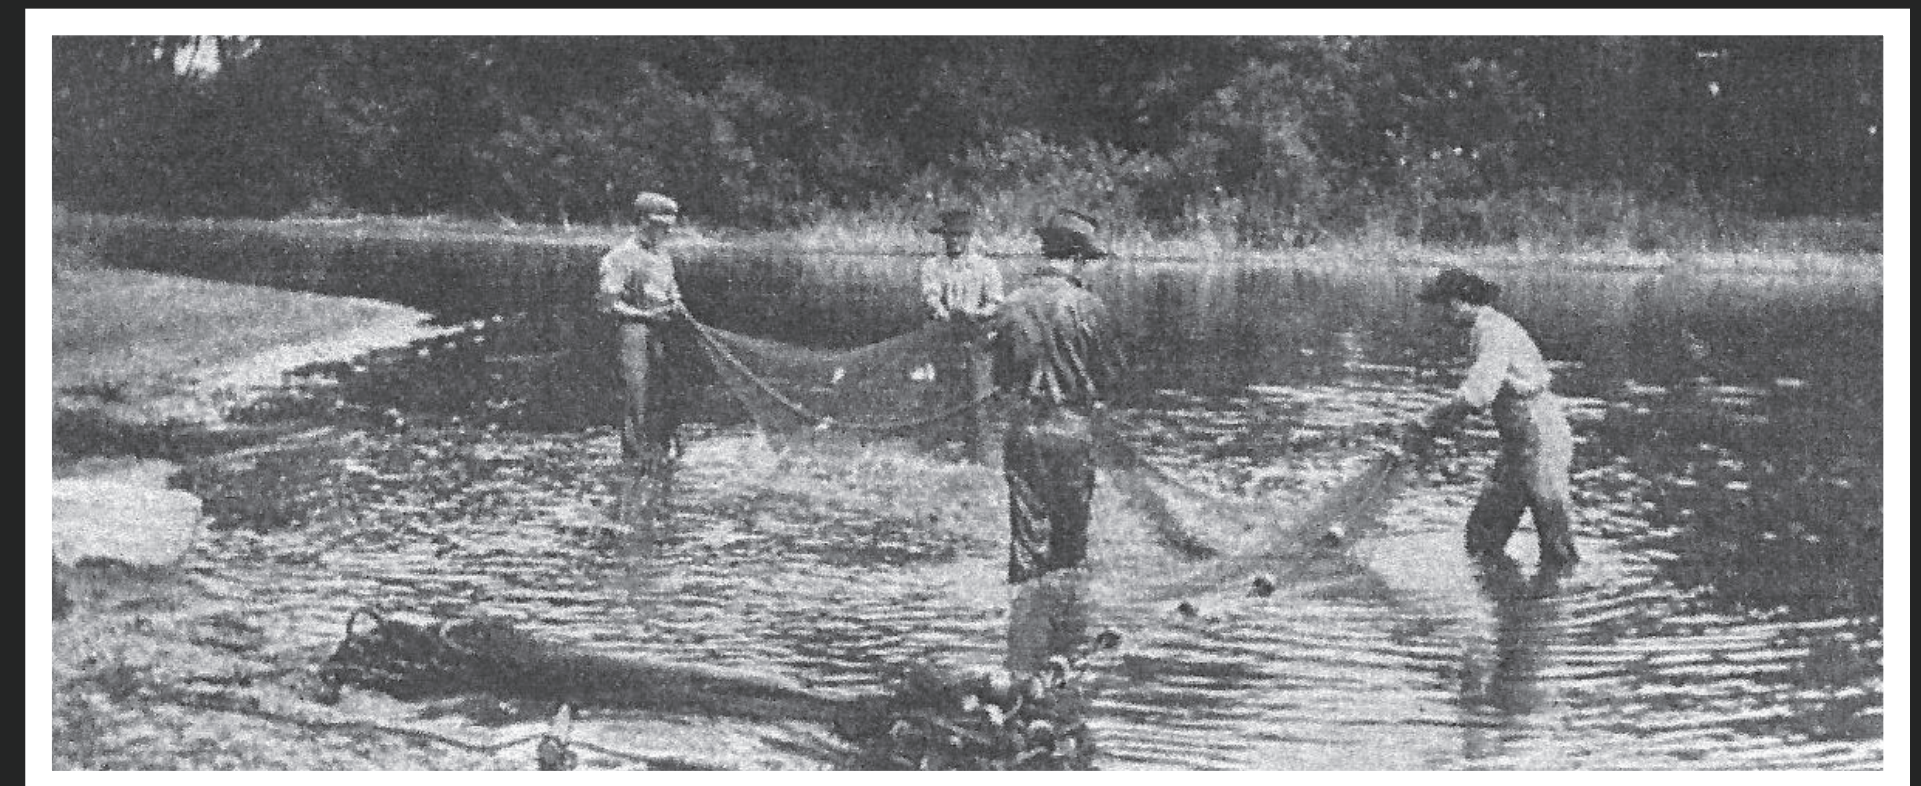
Seining for fish for infection with glochidia.

Daily operations were straightforward. Fish of one species were harvested and placed in a trough. Glochidia from the appropriate mussel were captured and then dispersed into the trough with the proper fish host. Fish were exposed to the glochidia for 10-20 minutes. After the fish gills were infected, the fish were ready to return to the river. Researchers soon learned that glochidia exposed to bright sunlight were less viable than those protected by shade. As a result, shelters were constructed over the exterior troughs. The change in ambient conditions paid large dividends for the researchers, providing more consistent and better results. With the termination of mussel propagation (early 1930s), the Tank House was converted to a holding house for fish and remained so until the hatchery-wide renovations in the 1950s. The Tank House was razed in 1952-53, and by 1954 the current administrative office was constructed on top of the original Tank House. An extension of the administrative office on the south side of the building was completed in 1984.
